## VWP FIELD INSPECTION CHECKLIST

| <b>Project Name</b> | Mountain Valley Pipeline Spread H, Roanoke County | <b>VWP Permit #</b> | N/A | <b>Inspection Date</b> | 9/20/2018 |

Site Name: Mountain Valley Pipeline\_Spread H; Wetland IJ-10

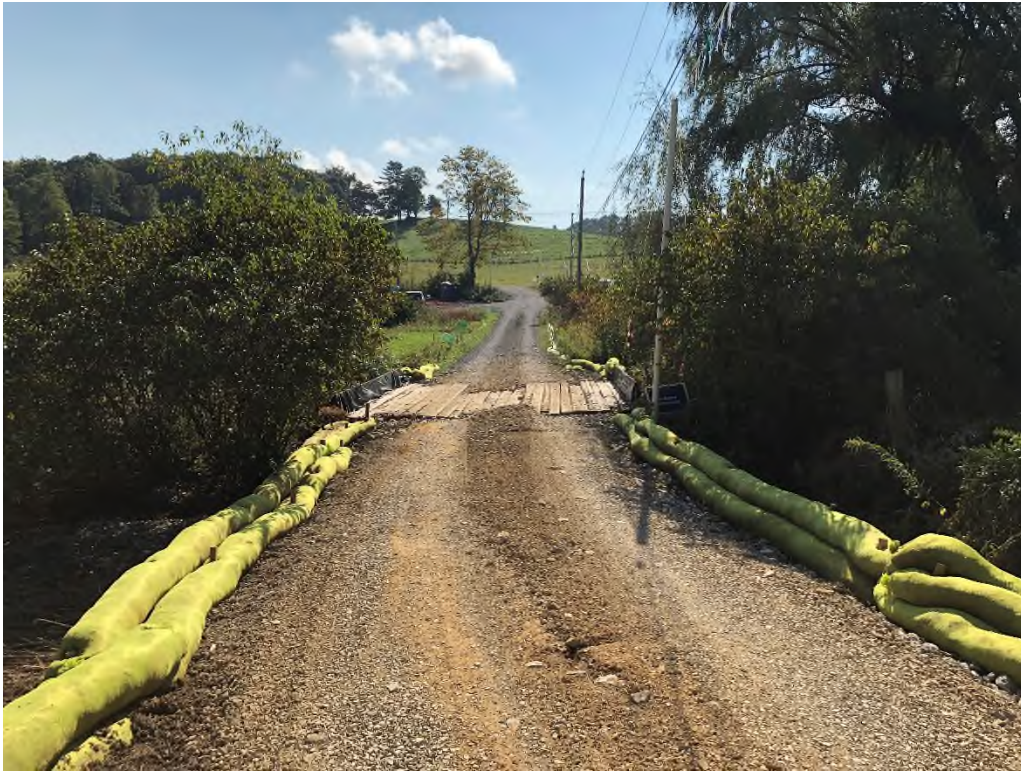
**Photo 1:** Access Road 288

Access Road 288 being maintained; ESCs replaced and functioning properly

**Orientation:** Facing Bent Mountain Road
