*Living Shoreline  
Sea-Level Resiliency:  
Performance and Adaptive  
Management of Existing Sites*

# Living Shoreline Sea-Level Resiliency: Performance and Adaptive Management of Existing Sites Summary Report

Shoreline Studies Program  
Virginia Institute of Marine Science  
William & Mary

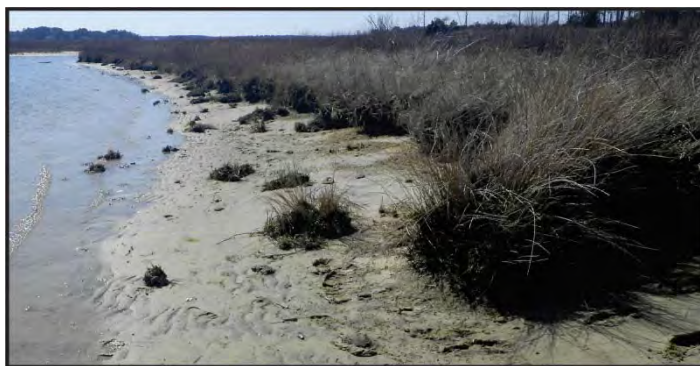
CSRA is set within the low lying landscape that surrounds the Mobjack Bay. The tidal shoreline is eroding marsh dominated by *Spartina patens* and black needle rush (Figure 4-1-2). Significant shore recession has occurred in front of the main house which has erosion rates of about 0.6 ft/yr. The tide range is 2.5 feet at the mouth of the Severn River. The project was designed to address shoreline erosion along the project coast. There is a fetch to the west of about 2.5 miles and the southwest of 1.8 miles, low medium energy exposure. The upper elevation of sand fill was set at +3.0 ft MLW and extends on a 10:1 slope to about mean tide level at the back of the proposed stone sills. Once established the project will provide an erosion-control marsh fringe. A new pier recently was built along the shoreline.

Figure 4-1-2. Conditions at Captain Sinclair before the project. Photo: Shoreline Studies Program, 1 April 2015.

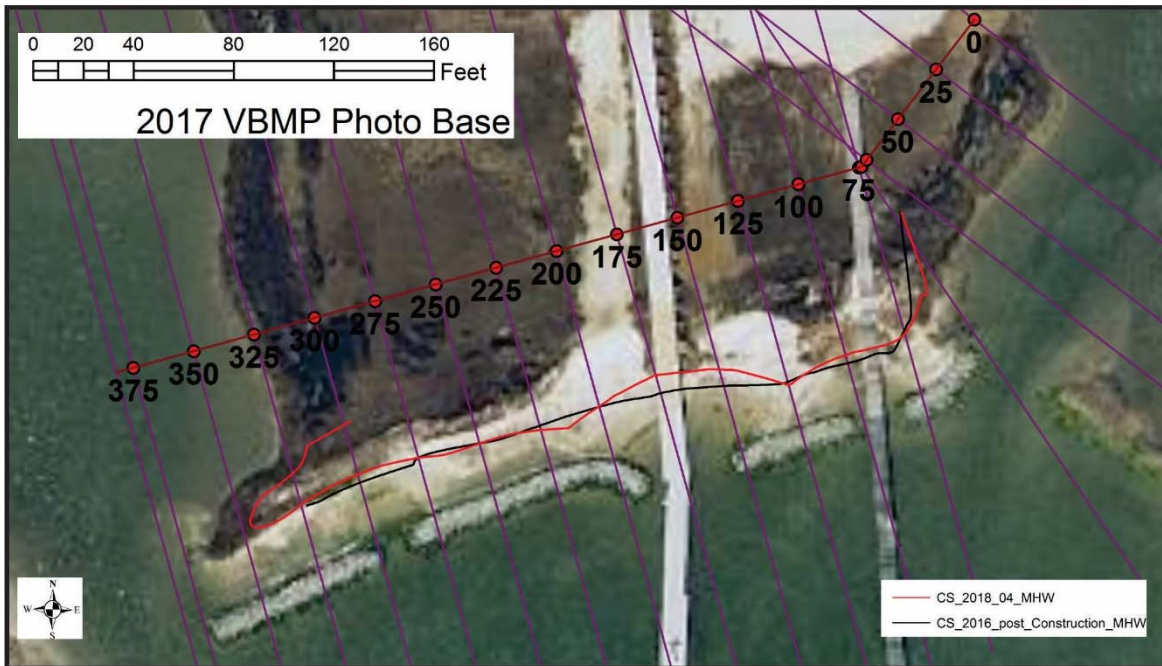
Figure 4-1-6. Basemap for Captain Sinclair showing the profile baseline and the position of mean high water in 2016 and in 2018.

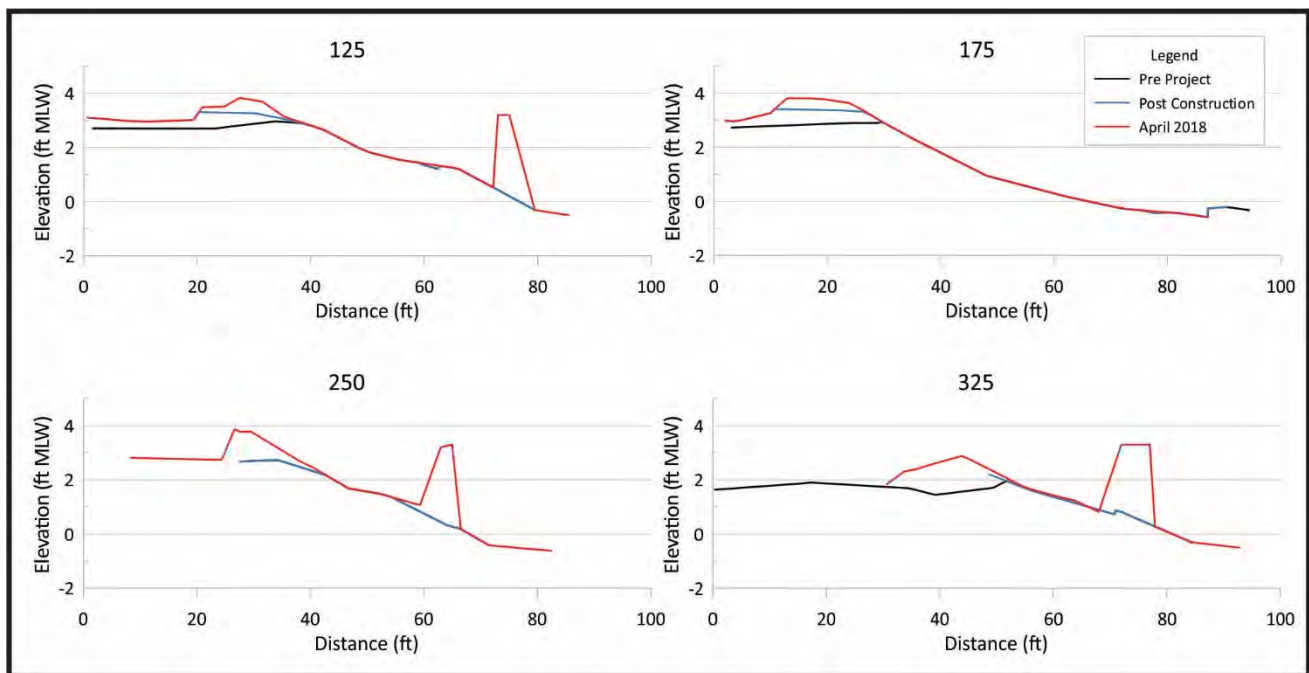
Site surveys show the main change is in backshore elevation (Figures 4-1-6 and 4-1-7). The backshore berm has increased in height and apparently not at the expense of the lower beach face. It appears that elevation changes are due mostly to vertical growth of the high marsh, *S. patens*, along the entire length of the project. An increase of almost one foot at profile 250. This bodes well for future adaptation to SLR.

Figure 4-1-7. Cross-sections of survey data for Captain Sinclair.

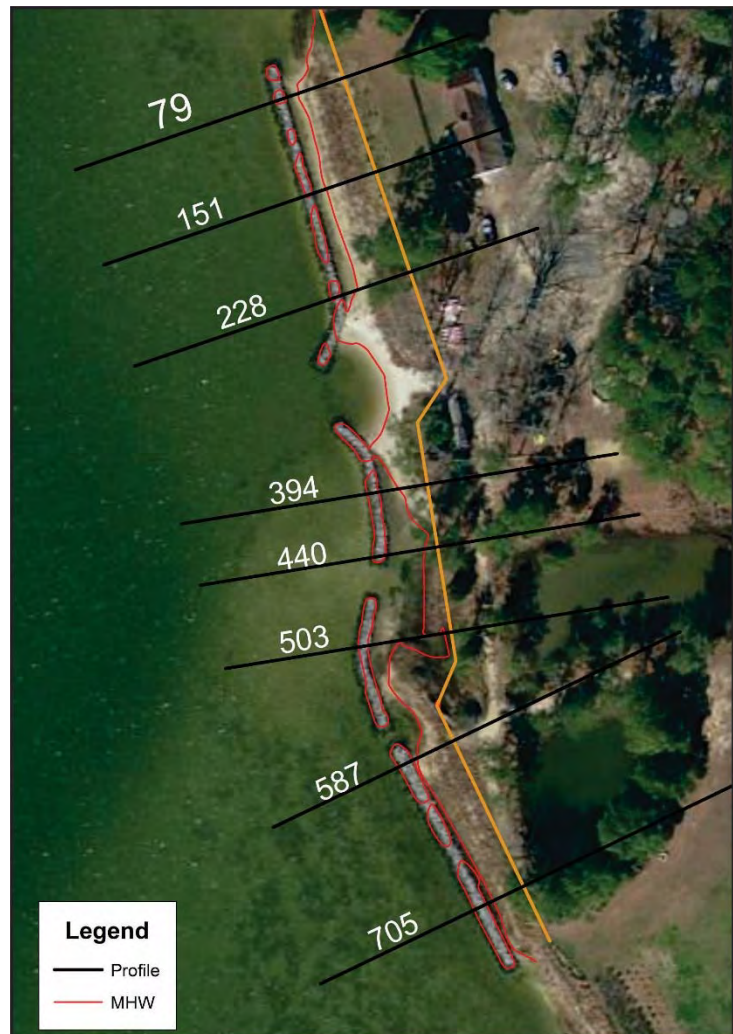
Figure 4-2-7. Location of cross-sectional profiles at Occohannock and the 2018 surveyed position of mean high water.

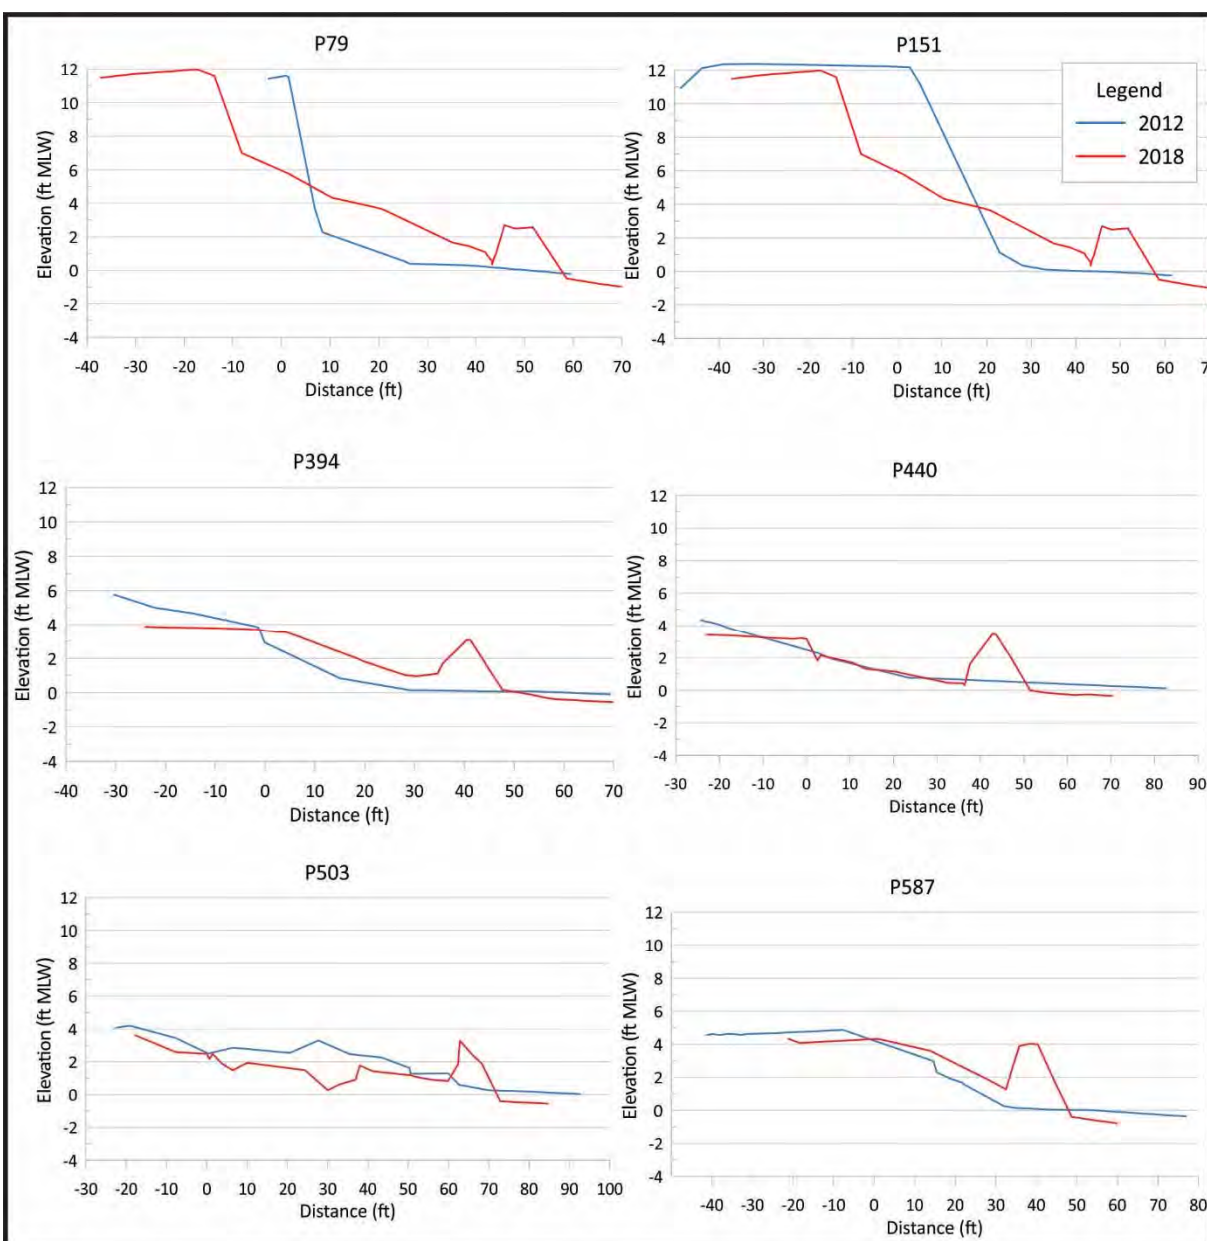
Survey data shows Reach 1 sill (ZZ) with elevated substrate from the sand fill in sections P587 (Figure 4-2-7 and Figure 4-2-8). The upland bank edge was graded slightly to the back of the sand fill. Reach 2, Sill 1 shows the mouth of the tidal creek has shifted and deepened slightly (P503). The tidal creek flat behind sill # 3, P440 has remained relatively stable transitioning to the sand fill going north, P 394. Reach 3 sections P151 and P79 show the graded bank and wide stable sand fill.

Figure 4-2-8. Cross-sectional profiles at Occohannock taken before the living shoreline project was installed and in 2018.

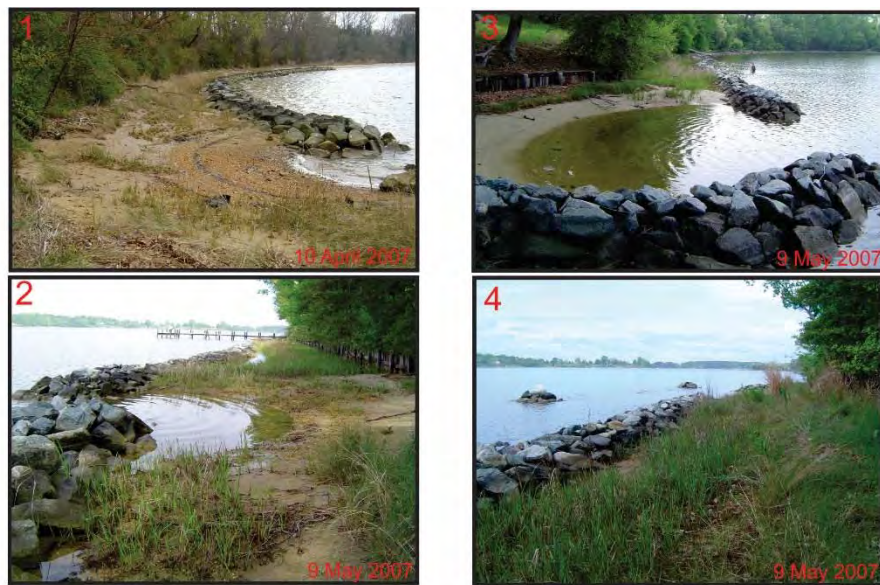
Figure 4-3-2. A photo mosaic of the St. Mary's City, Maryland shoreline on August 24, 2007 indicating the four sites of gapped fill projects and ground photographs of each site.

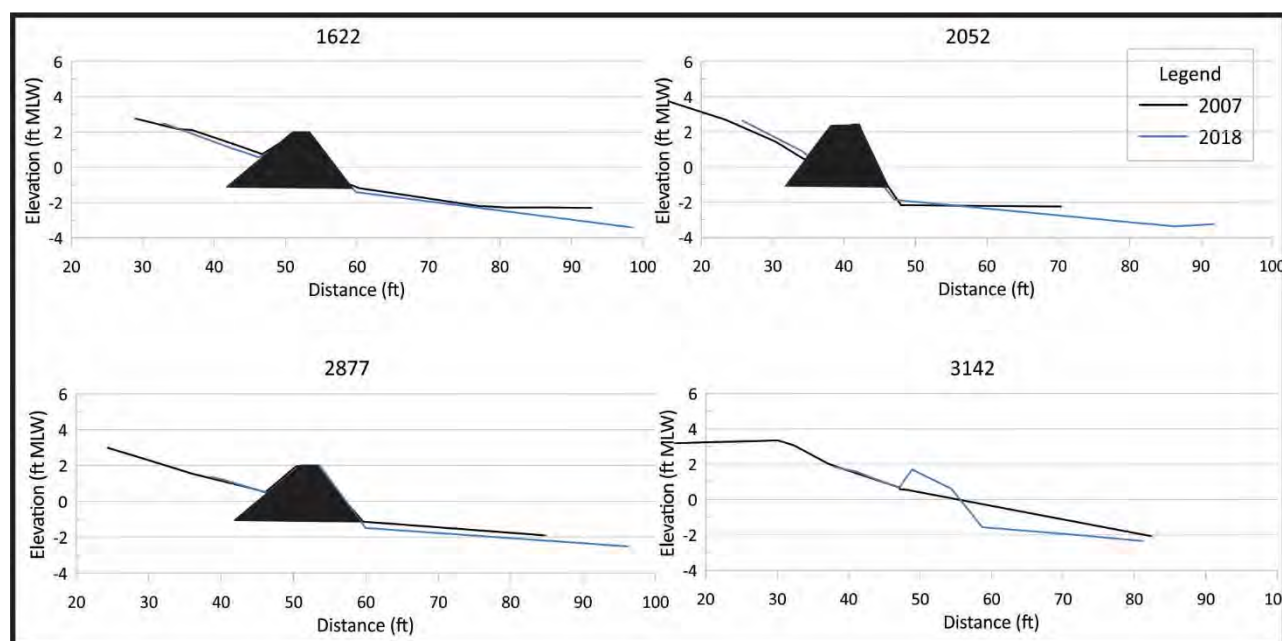
The survey showed that there were gradient adjustments between construction and the 2008 survey, but since then the net change across the stable vegetated backshore has very been little with some areas of reduction usually between +1 ft and +2 ft. This is the high water swash zone, where grasses are under the most stress from wave impact. Changes are in the order of 0.1 to 0.3 ft. Little new sediment enters the system either from the upland banks because they are very stable or from offshore due to the rock sill barrier.

Along Sill #1, there were slight decreases in the lower limit of *S. alterniflora* and in the nearshore (1622). Sill #2 (P1955), the backshore remained stable while behind Sill #3 (P2052) there was a slight increase, +0.3 ft from the back of the sill to about +2.5 ft at the edge of the heavy backshore vegetation. Further up at Sill #6 (P3142) shows no change across the backshore. We estimate almost 10

Figure 4-3-11. Selected cross-sectional profiles showing the shoreline in 2007, 5 years after construction and in 2018.

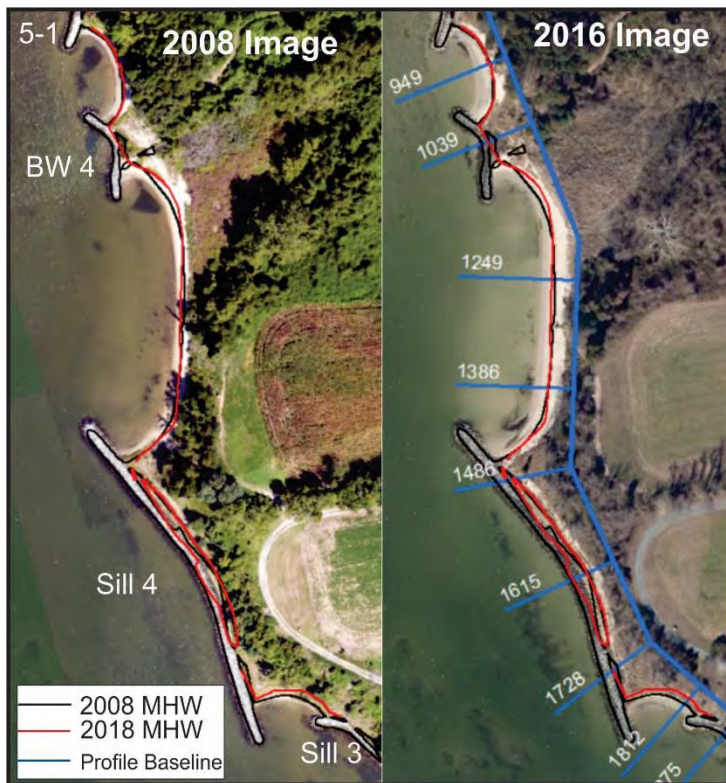
Figure 4-4-8. Aerial photos taken in 2008 and 2016 showing the cross-sectional profile locations and the surveyed position of mean high water in 2008 and 2018.

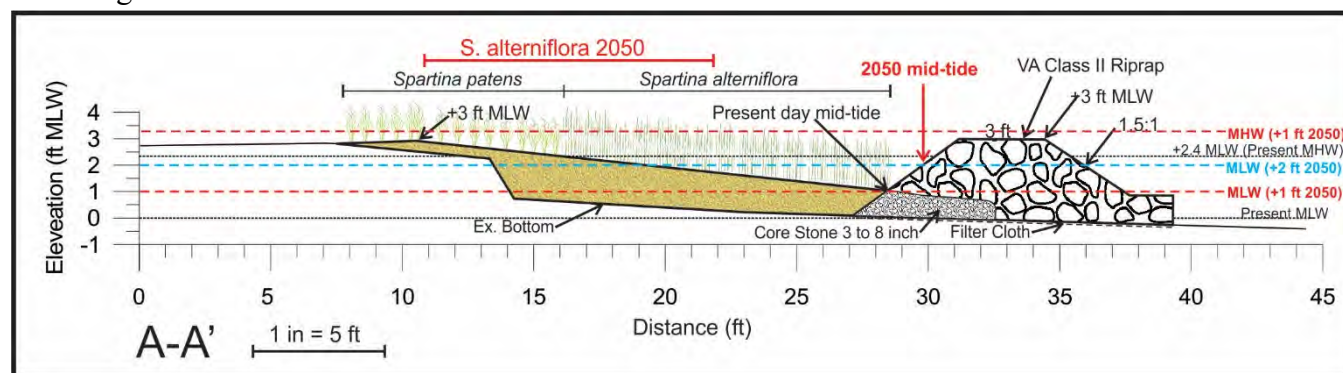
Based on the model at Captain Sinclair, the lower limit of *S. alterniflora* will be about 8 feet landward of the sill (5-1-1) because mid-tide, which is the lower limit of *S. alterniflora*, extends farther inland. The *S. patens* along the back berm will be replaced by *S. alterniflora*. The sill will become submerged at MHW thereby slightly reducing its wave attenuation capability but also becoming more of reef type structure. Adding rock to the sill is not an option because this low bank shore will be flooded. If this system is able to migrate vertically and horizontally either naturally or with the addition of sand, by 2050, it will have preserved about 0.14 acres of marsh habitat.

Beyond 2050 (or increased rate of SLR), the marsh system will begin to drown. At an increase of 2 ft in sea level, the system will become almost subtidal and the wide marsh behind the sills will be impacted. The rock sill will become a fully submerged reef which will still reduce wave energy impacting the shoreline, but it will not provide effective shore protection. Once the system is subtidal, SAV might move into the old marsh substrate.

Figure 5-1-1. Sea-level rise scenarios modeled at Captain Sinclair and depicted on a typical cross-section.

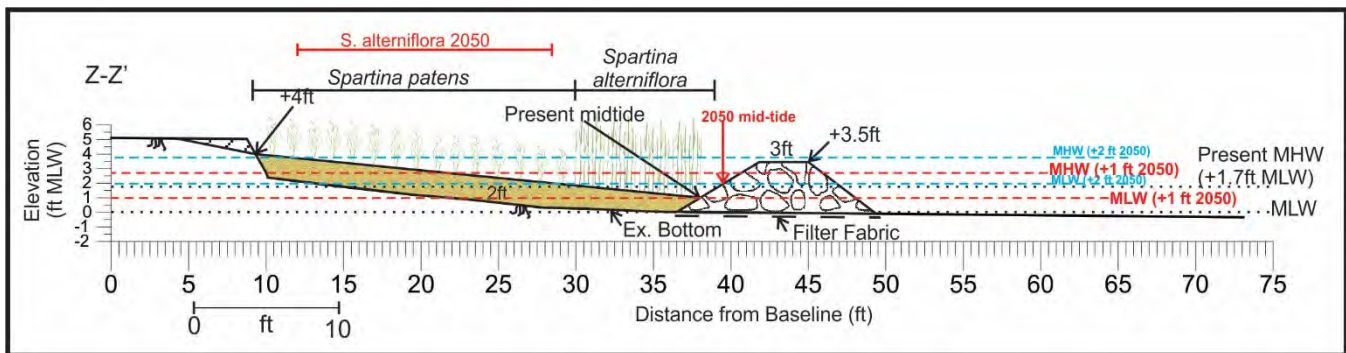
By 2050 with a 1 projected one-foot rise in sea level, impacts will have different impacts to the various Camp shorelines. In Reach 1, the sill should still be functioning to attenuate waves because it is still exposed at high water. However, the low marsh fringe will recede 8 to 10 feet (Figure 5-2-1). The high marsh and salt bush will occupy a narrower corridor. One more foot of SLR will submerge the sill at high water and drown much of the high marsh leaving only a narrow section of low marsh and

broader subtidal terrace. The upland will be just above MHW so the access path might become a high marsh terrace. More wave energy will impact the site, and an increase in rock height maybe warranted.

Figure 5-2-1. Sea-level rise scenarios modeled at Occohannock, Reach 1, and depicted on a typical cross-section.

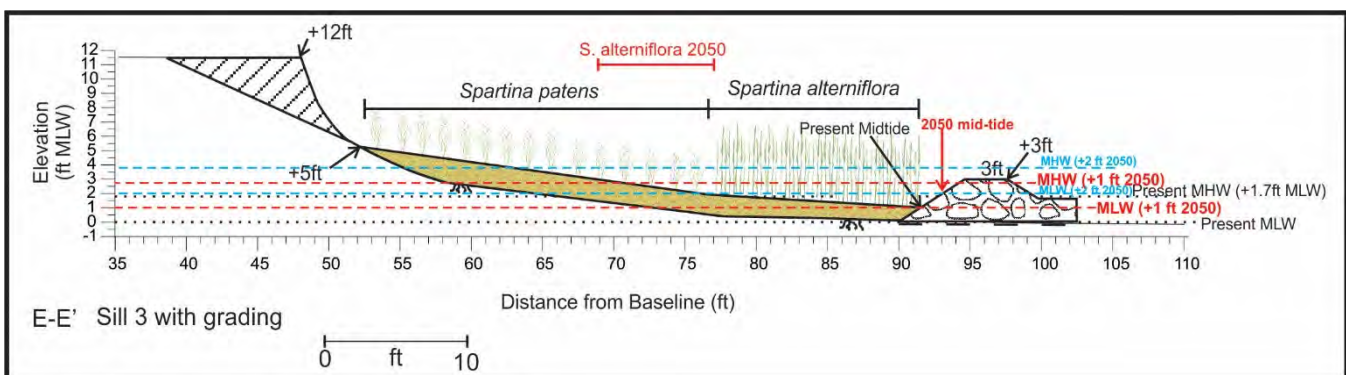
The upland bank along Reach 3 under the 1 SLR will still be protected by the marsh fringe even though MHW and the low marsh will move landward 5 to 7 feet and the rock sill will be almost submerged at high water (Figure 5-2-2). Much of the lower marsh area today will become intertidal non-vegetated wetlands, and only a small area of *S. alterniflora* will exist because of the steeper elevation between the low marsh and the bank. A 2 foot SLR may warrant the addition of rock to the sill which will be one foot underwater at high tide because the marsh fringe and base of upland bank may also become compromised because of increase in wind wave impacts during even modest storm events.

Figure 5-2-2. Sea-level rise scenarios modeled at Occohannock, Reach 3, and depicted on a typical cross-section.

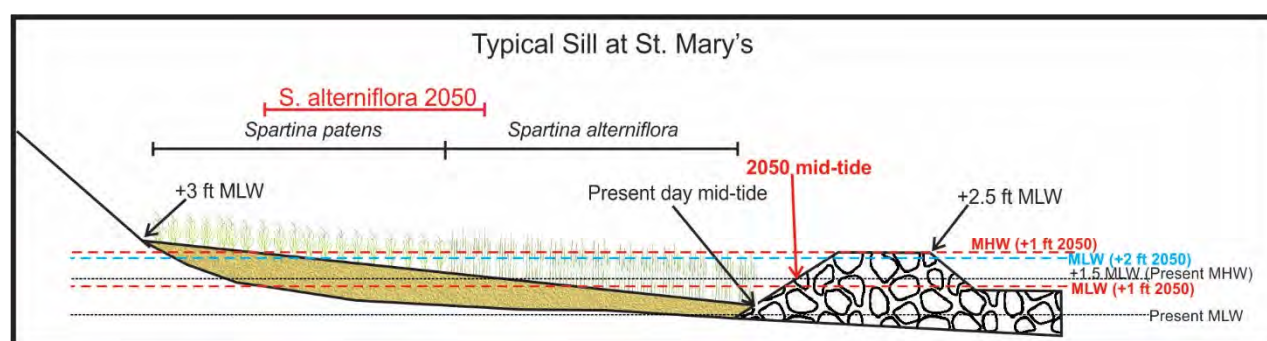
Mean sea level has risen about 0.2 ft since the project was installed. On the original design, the total sea level rise modeled by 2050 includes the 1-foot projected sea level in addition to the 0.2 ft that has already occurred. This means that the 2050 MHW will be +3.2 ft above the position of MLW in 2002. This moves the lower limit of *S. alterniflora* landward over 10 feet which amounts to significant “coastal squeeze”. The rock sill is submerged at MHW and the base of the bank will also be flooded (Figure 5-3-1). The existing vegetation will change and the Phragmites may disappear as it is submerged twice a day. high marsh and wave attenuation of the sill will be reduced. The intertidal and subtidal area will expand behind the sill. A 2-foot rise will submerge the whole system at low water.

Figure 5-3-1. Sea-level rise scenarios modeled at St. Mary's and depicted on a typical cross-section.

Presently, the system is working to provide shore protection to the high bank coast along this relatively low fetch shoreline. However, this site maybe a candidate for SLR modifications in the future due in part to ease of accessibility by water which will allow barges to bring in material and to be used in construction. One scenario would be to add proportionate rock and sand to the system and replant after cutting back the overhanging limbs (Figure 5-3-2). The existing marsh fringe would be completely covered, and the project would start all over again at a higher elevation. Before this could be implemented, it would be important to dig out all the Phragmites and commit to a maintenance plan.

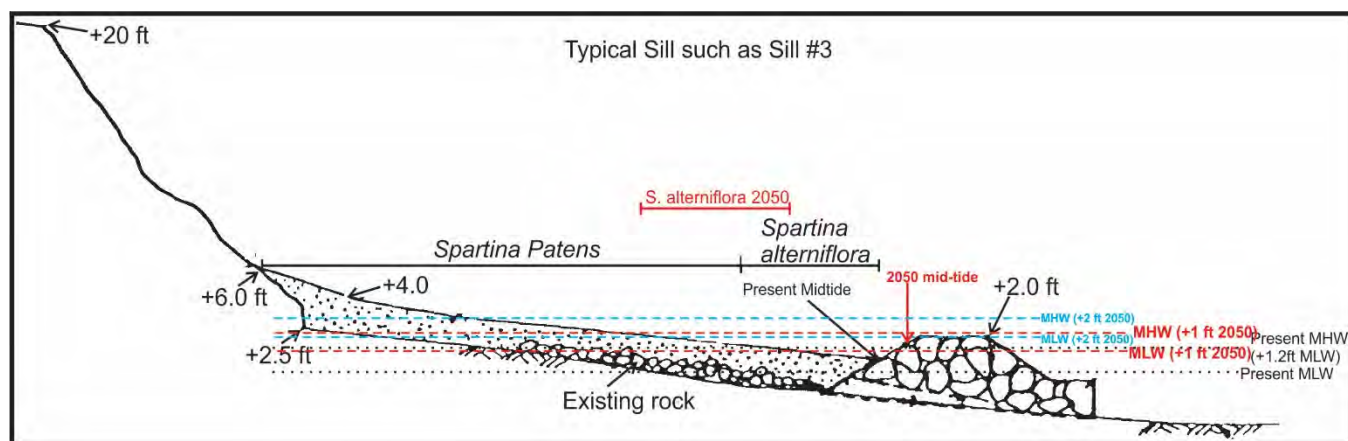
With a one-foot rise in sea level, *S. alterniflora* would migrate updrift leaving a wider non-vegetated intertidal zone. The sill would be submerged at high water (Figure 5-4-1) The extensive *Phragmites* already covers much of the sill system and would persist even with a 2-foot rise in sea level. This system would be a good candidate site for just adding rock to the sill to protect the base of bank from wave attack (Figure 5-4-2). Adding sand could be done too but at additional costs. Again these options are viable because of barge access for construction.

Figure 5-4-1. Sea-level rise scenarios modeled at Jefferson Patterson and depicted on a typical cross-section.
