# **Living Shoreline Sea-Level Resiliency: Performance and Adaptive Management of Existing Sites**

## **Year 3 Summary Report**

**Donna A. Milligan  
C. Scott Hardaway, Jr.  
Christine A. Wilcox  
Nick J. DiNapoli**

**Shoreline Studies Program  
Virginia Institute of Marine Science  
William & Mary**

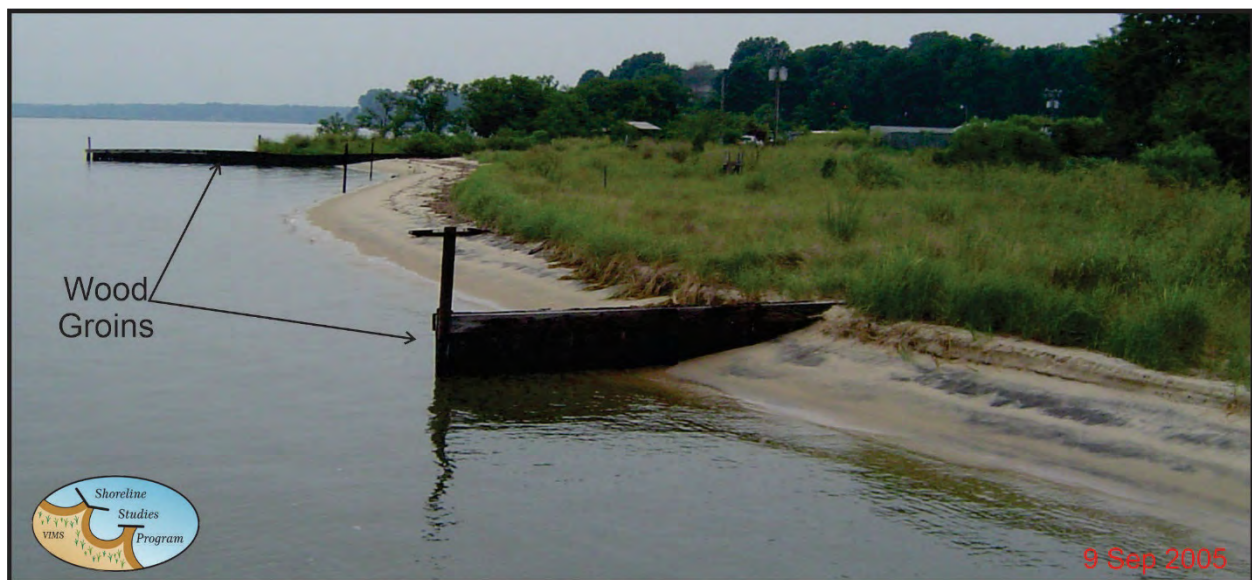
Figure 6-8. The VIMS West coast was a low eroding shoreline with wood groins for shore protection prior to installation of the breakwaters. Photo credit: Shoreline Studies Program, VIMS

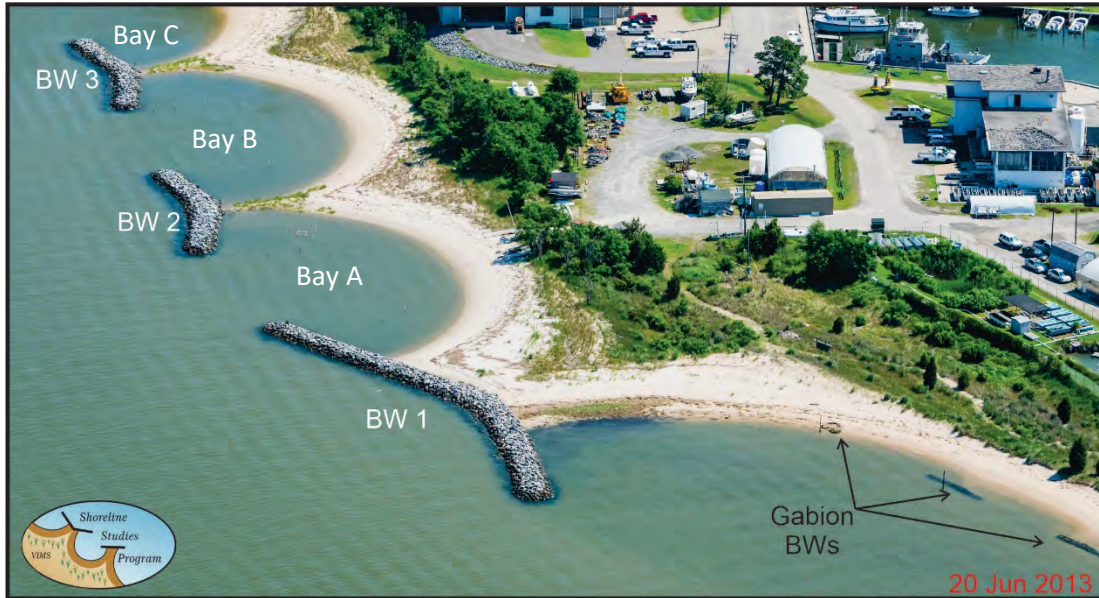
Storms impacted VIMS West after the project was installed, particularly in 2012 (Hurricane Sandy) and in 2013 (March Extratropical Cyclone). As shown in Figure 6-12, water levels completely overtopped the structures at VIMS West. As a result, the subaerial attachment at breakwaters 2 and 3 became narrow. However, maintenance planting and natural marsh vegetation colonized the attachment (Figure 6-13). Over the next six years, natural low marsh vegetation increased behind breakwaters 2 and 3, increasing the width of the attachment (Figure 6-14). In addition, the gabion breakwaters that were uncovered are functioning as semi-detached breakwaters. The channel jetty spur supports that embayment, Bay A.

Figure 6-13. Aerial photo taken in June 2013 showing VIMS West 2.5 years after construction.

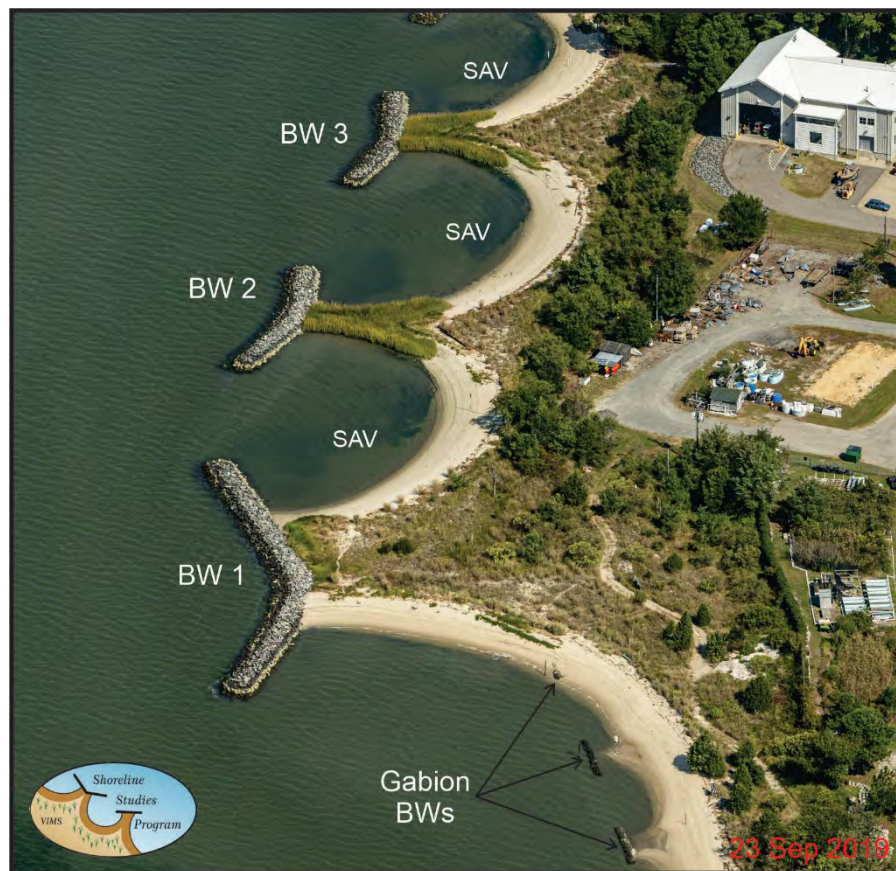
SAV occurs in the embayments. Prior to the installation of the breakwaters, historical SAV records show that the underwater grasses come and go at the site. Yearly records indicate a lack of SAV at the site between 1971 and 1990. After that, patches occurred at the site until 2002 when the nearshore was covered with SAV along the entire site. However, that coverage declined until no SAV existed in 2007. With the construction of the breakwaters in 2010, the opportunity existed for SAV to colonize the shallow embayments between the structures, and presently, a large amount of SAV occurs at the site (Figure 6-14).

Figure 6-14. Aerial photo taken in September 2019 showing VIMS West nearly 9 years after construction.

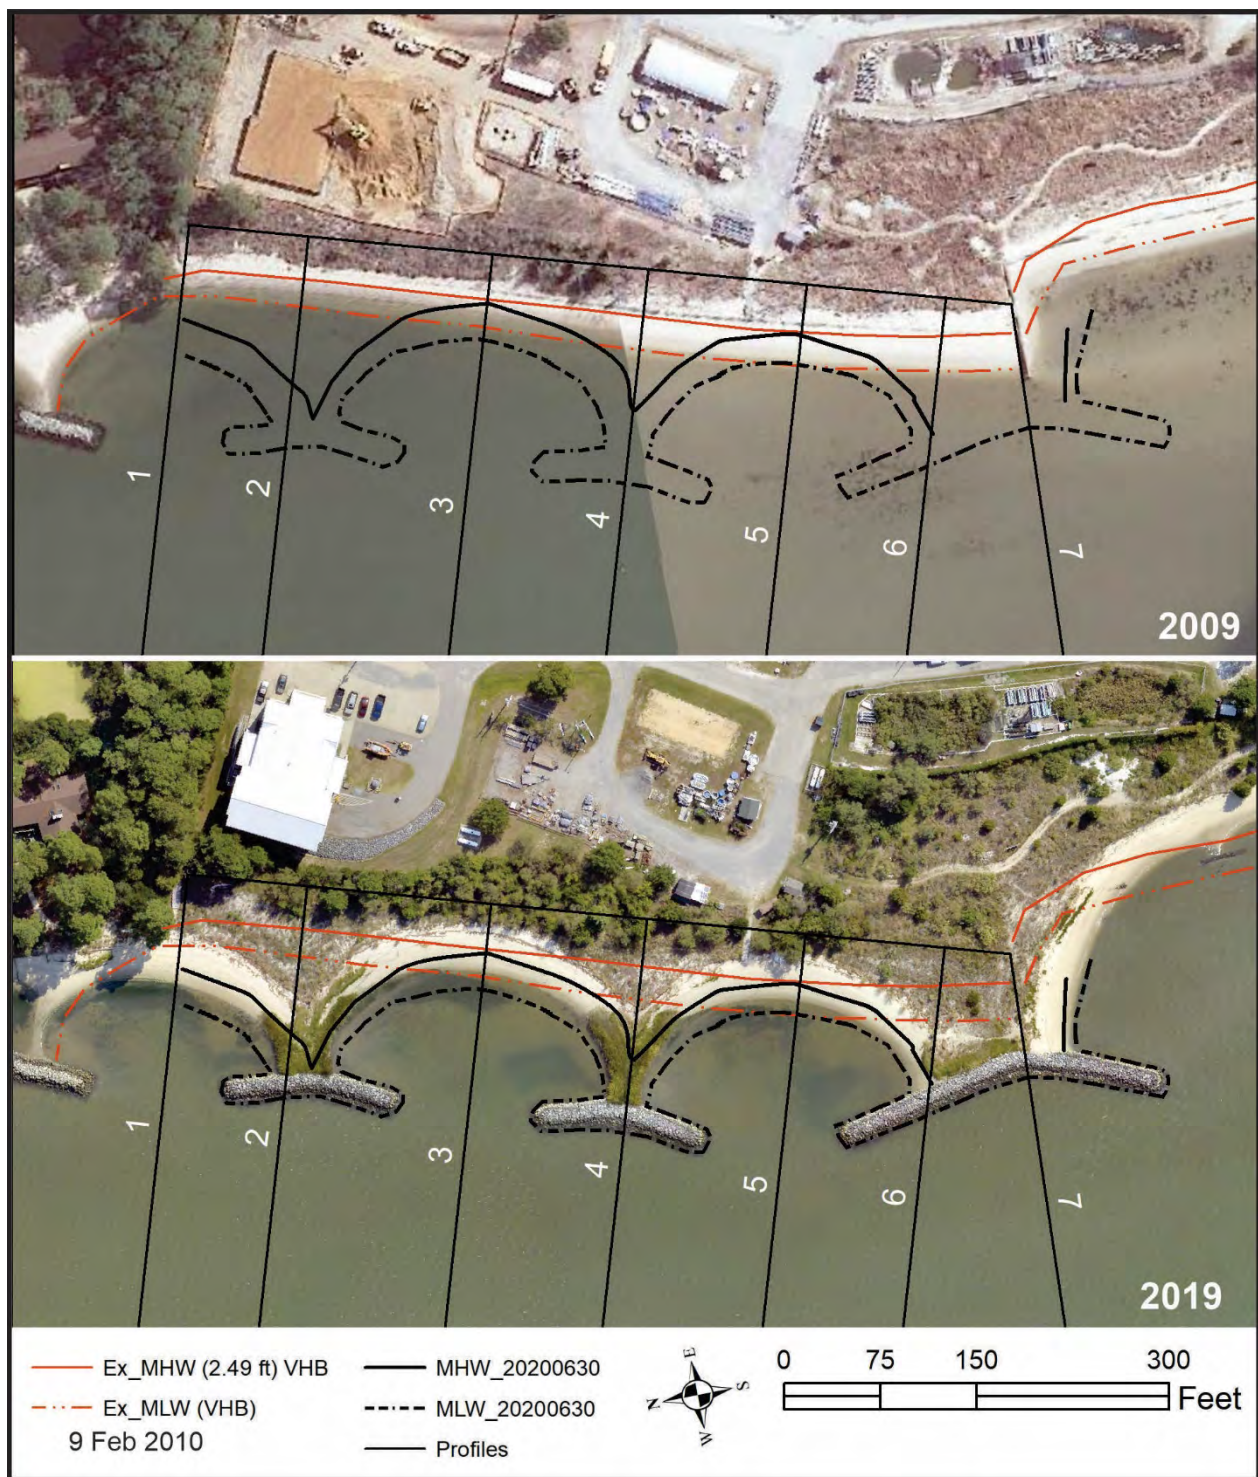
Net change in shoreline position is dramatic pre-post project (Figure 6-15). In some areas, the position of MLW is shifted over 100 ft riverward. The center of the embayments had the least change between pre and post construction. All profiles showed a large volume of sand placed except Profile 5 (Figure 6-16). Since construction, generally, the upriver section of

Figure 6-15. Survey data analysis at VIMS West showing the position of MHW and MLW before construction in February 2010 (VHB survey) and in June 2020, about 9.5 years after construction. Top photo base is 2009 VGIN image, bottom image is SSP's September 2019 image.

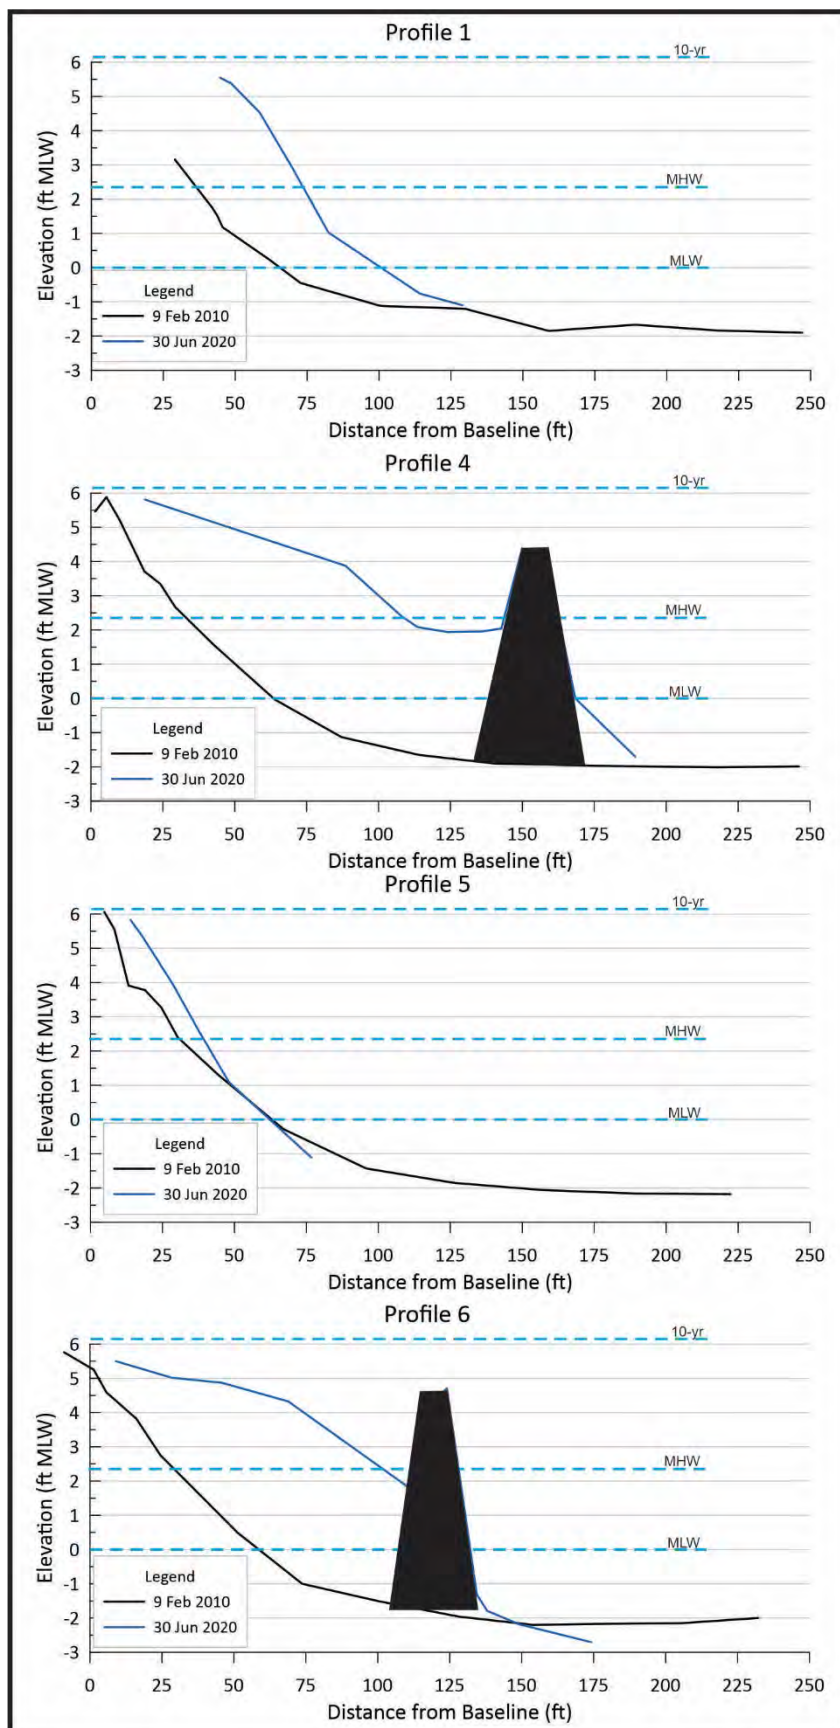
Figure 6-16. Profile data taken in February 2010 (pre-construction, VHB survey) and in June 2020 by SSP.

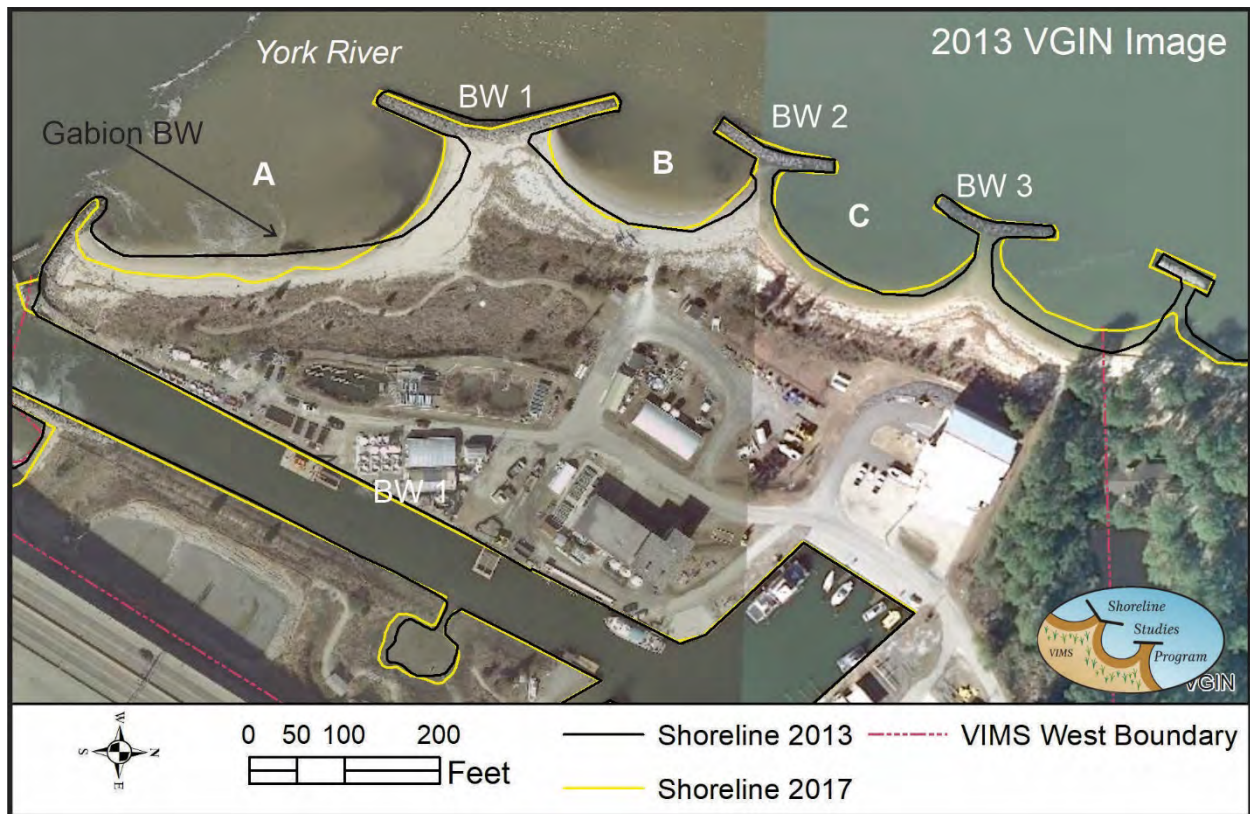
shoreline is accreting (north of BW3), embayments B and C are stable, but embayment A is still equilibrating to its equilibrium position (Figure 6-17). The gabion breakwaters have become uncovered and are influencing the shoreline in embayment A as well.

Figure 6-17. A 2013 VGIN photo showing the 2013 and 2017 digitized shorelines.

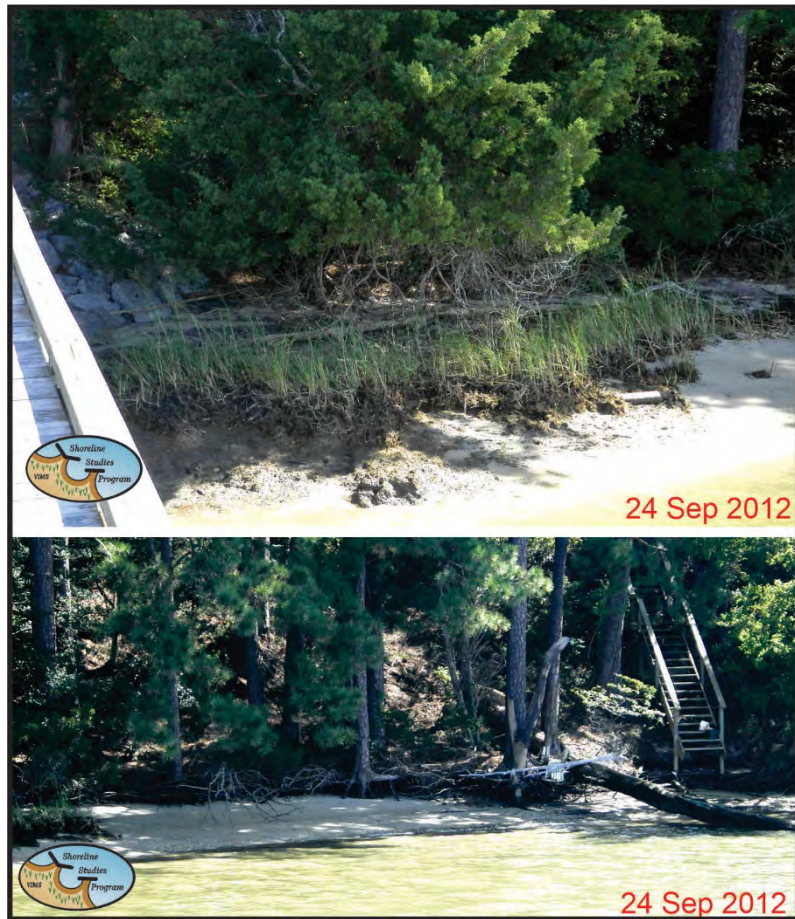
Several sections of the York River shoreline are protected with a high sill in front of the house and a revetment along the York River shoreline closer to Bland Creek. However, the section of shoreline near the pier was eroding into the bank (Figure 7-4). Great concern existed for the loss of high value archaeology associated with Powhatan and the Native American occupation of the site due to continued erosion of the bank in unprotected areas. This resulted in the construction of a stone gapped sill living shoreline system (Figure 7-1).

Figure 7-4. Werowocomoco shoreline and eroding upland bank in 2012. Very little of what used to be an extensive marsh fronting the upland bank remained, and the bank was being directly impacted by high water levels during storms. Photo credit: Shoreline Studies Program, VIMS.

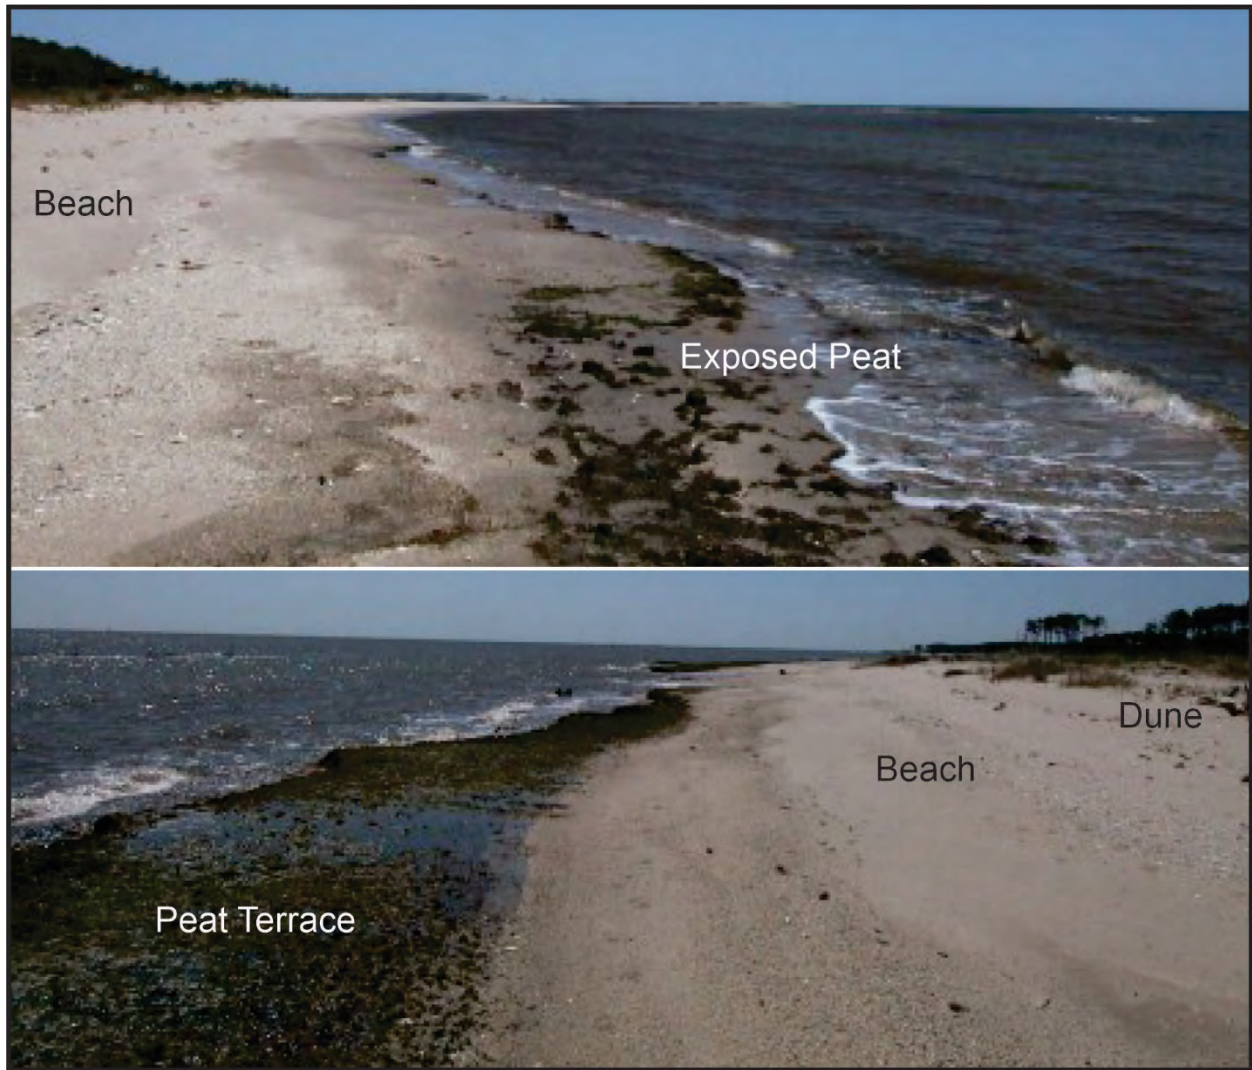
Figure 8-6. Photos at Haven Beach submitted with the Virginia Marine Resource Commission permit application #20022188. Top shows the view looking north along the site and bottom shows the view looking south. Exposed peat and wider peat terraces occur along the site. Above these, a beach and dune/washover occur.

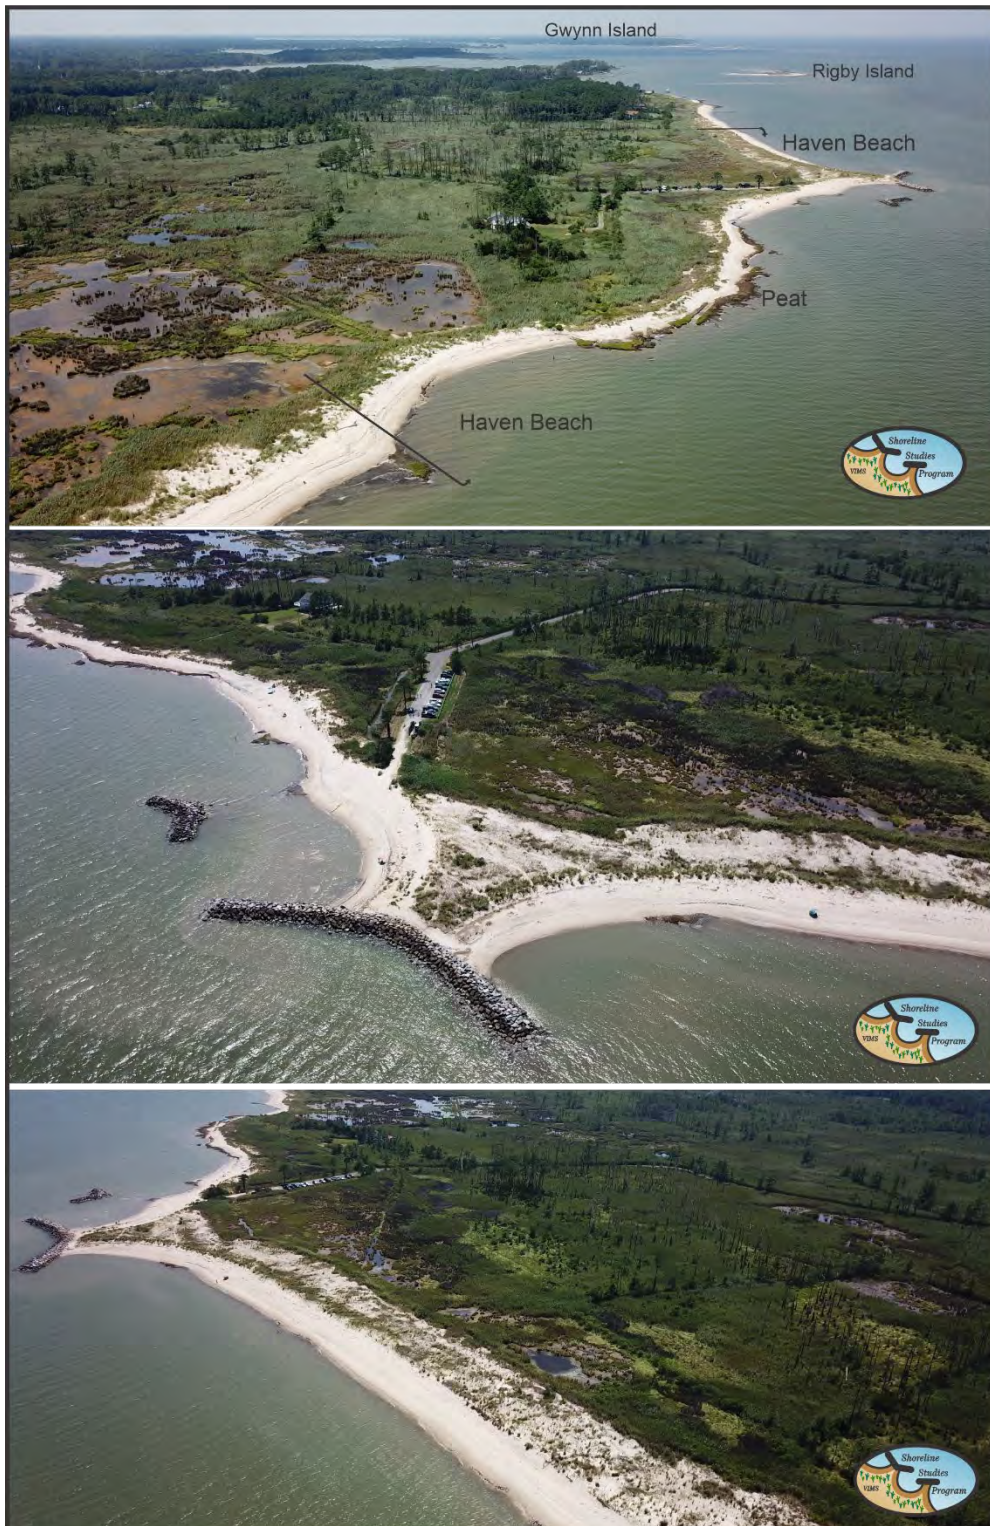
Drone imagery taken 30 July 2020 shows the system as it occurs today (Figure 8-8). The top image shows a long view of the site from the south. Peat outcrops occur along the shoreline south of the breakwaters. Near the southern boundary of the site, a small sand embayment occurs between two peat headlands. In some areas, the peat forms a wide terrace south of the breakwater that has supported the regrowth of smooth cordgrass. Sandy beaches front washover dunes and vegetated and non-vegetated wetlands. The middle photo shows a closer view of the breakwaters that were installed in 2005. The tombolo behind the large breakwater is heavily vegetated, but no sand occurs behind the small breakwater.

Due to the southerly movement of sand along this section of shore, sand accumulated updrift of the large breakwater over time, and the northern section of Haven Beach became a sandy beach/dune complex vegetated by dune grasses (Figure 8-8, bottom). This beach/dune fronts the marsh and provides protection during storms. Though the large breakwater is functioning well as shore protection, the smaller breakwater has not been able to withstand the storms that have impacted the site. Most of the sand was lost from behind during a storm in 2015 (Hamilton, 2016).

Figure 8-8. Drone imagery taken in July 2020 showing the evolution of Haven Beach. Top: the boundaries Haven Beach are shown. South of the breakwaters, erosion is still occurring and peat is exposed. Middle: The tombolo behind the large breakwater is well-formed with beach and dune vegetation while no sand occurs behind the small breakwater. Top: North of the breakwater, a large beach/dune system has grown since installation of the structures.

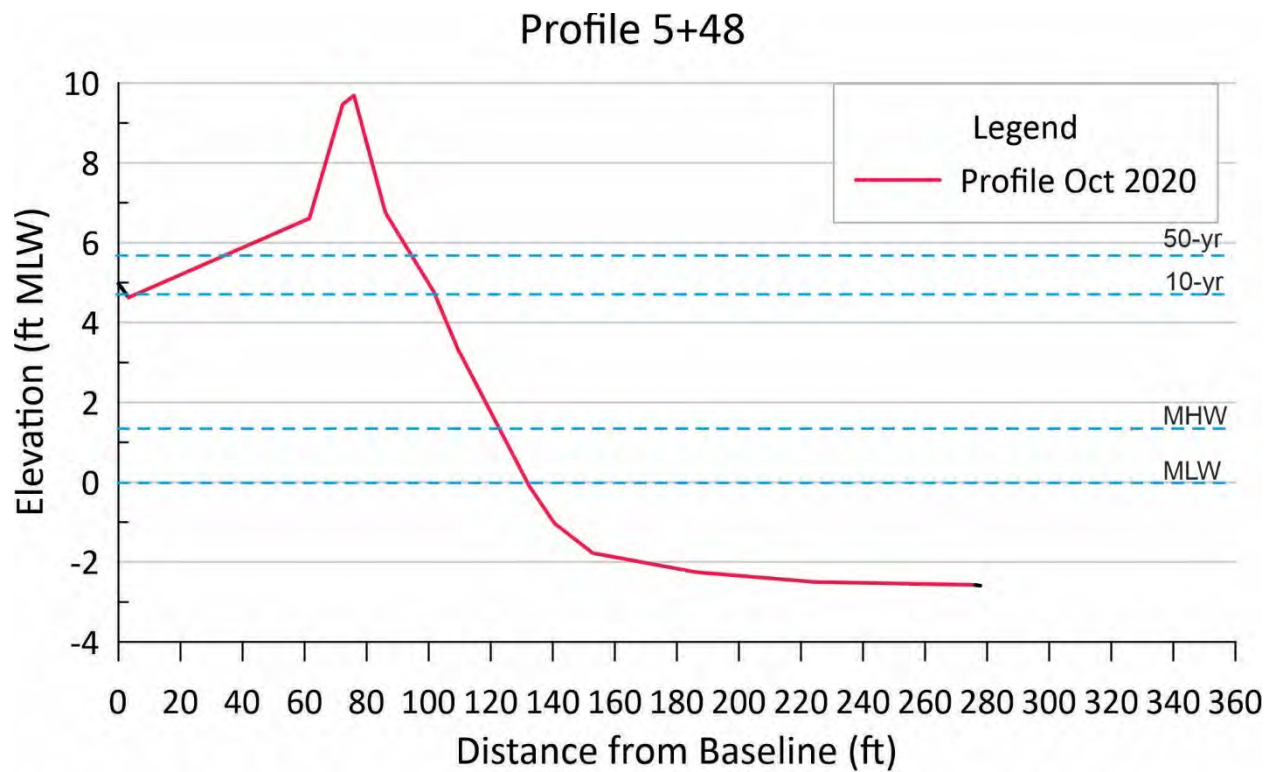
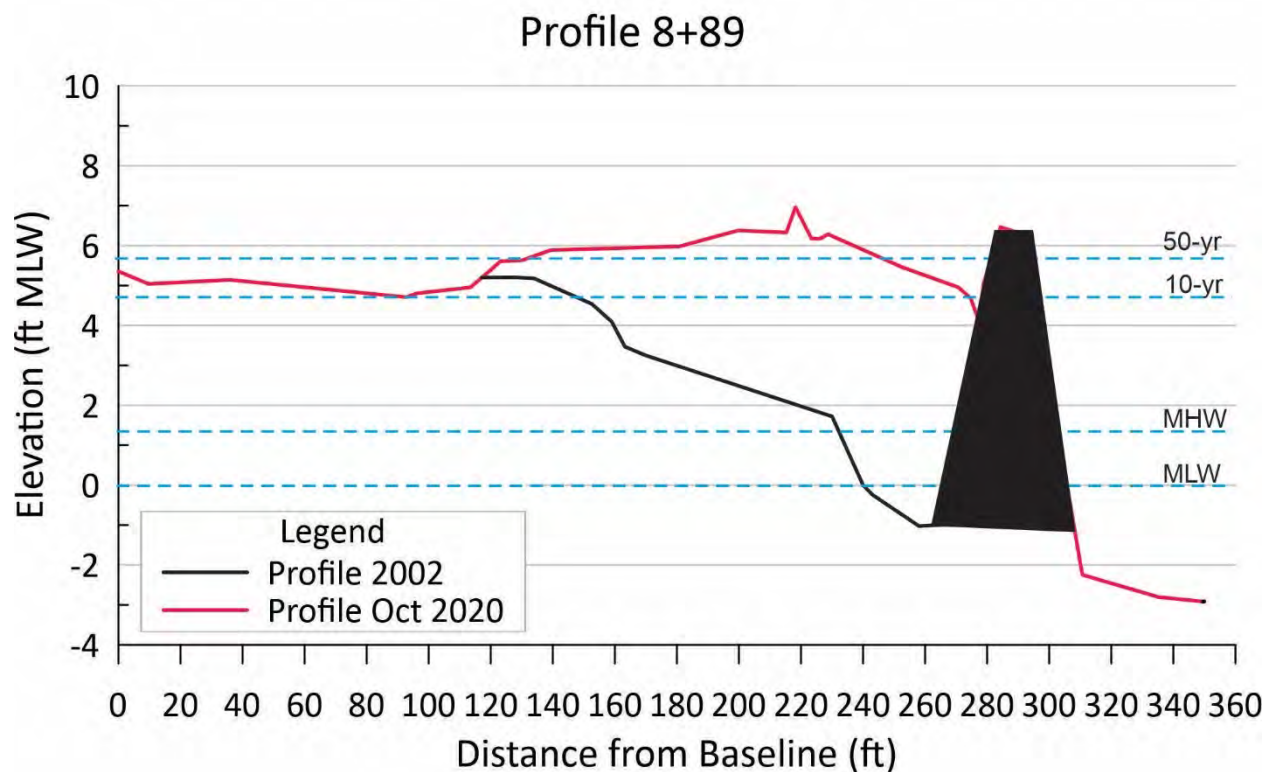
The site was surveyed in October 2020 (Figure 8-9). Survey data cross-sections show the development of the site over time. On the northern section of the site, a high, wide dune has grown over time. Survey 5+48 (Figure 8-10) shows that the crest elevation of the dunes is nearly +10 ft MLW and provides protection for the lower marsh behind it. The breakwaters were designed at +6 ft MLW as shown by cross-section 8+89 (Figure 8-10). Survey data taken in 2002 for another SSP project shows that prior to the project, the shoreline was low with very little protection for the marsh behind the beach. Though the as-built survey could not be obtained, it is likely that the tombolo has accreted and become higher behind the structure. With the high breakwater structure and the very wide tombolo, waves are mitigated during storms reducing impacts to the marsh behind.

Figure 8-10. Cross-shore profiles at Haven Beach. Top: profile 5+48 shows the high wide dune that exists north of the large breakwater. Bottom: profile 8+89 crosses the large breakwater and shows the change between 2002 and 2020.

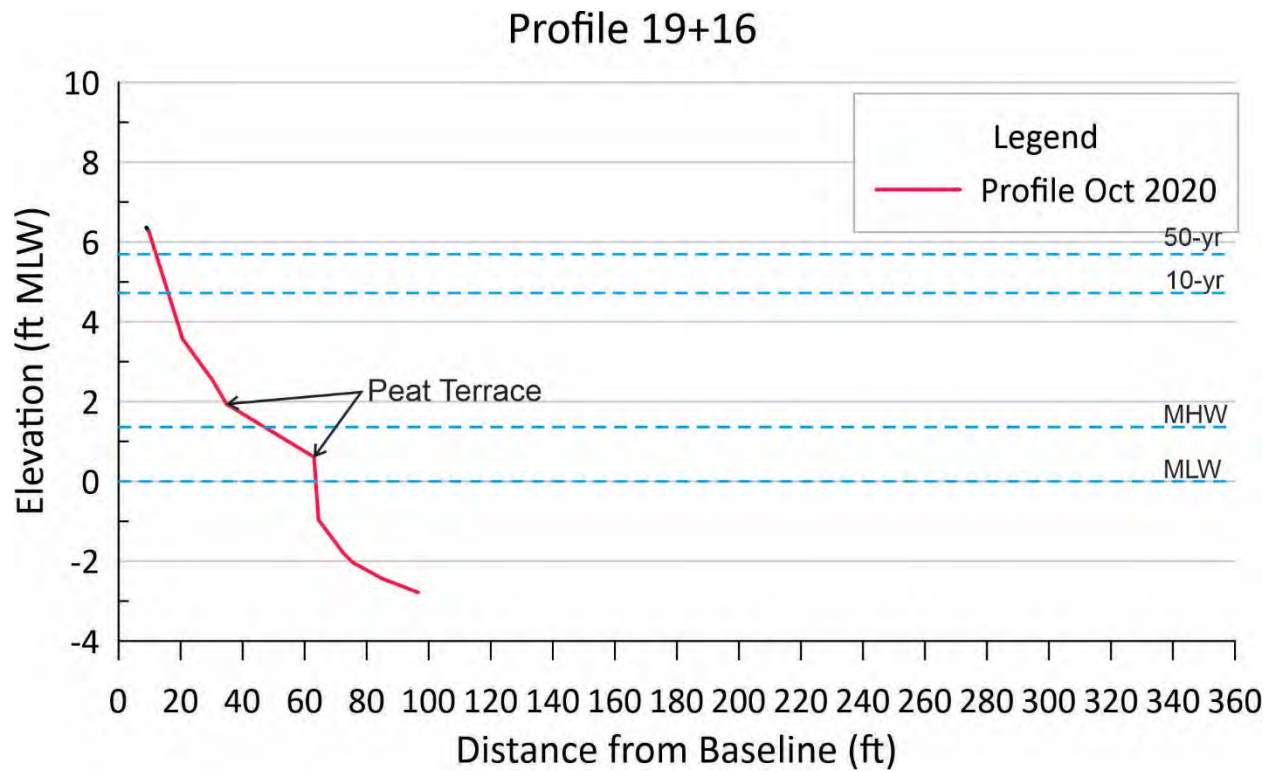
At profile 19+16, no pre-project profile exists (Figure 8-12). The effect of the shore protection project is lessened at this distance from the breakwaters, though the maximum elevation of the beach/dune is slightly higher than the pre-project profiles north of here. Those elevations were just over +5 ft MLW as shown on profiles 8+89, 11+65, and 14+14. However, presently at profile 19+16, the maximum elevation of the beach/dune is at about +6.5 ft MLW. Also, a 30 ft wide peat terrace occurs along this profile. It has a flatter slope than the surrounding sand and occurs between about +2 ft MLW and mid-tide. This peat outcrop creates a headland

Figure 8-12. Cross-shore profile 19+16 at Haven Beach south of the breakwaters shows the wide peat terrace that occurs.

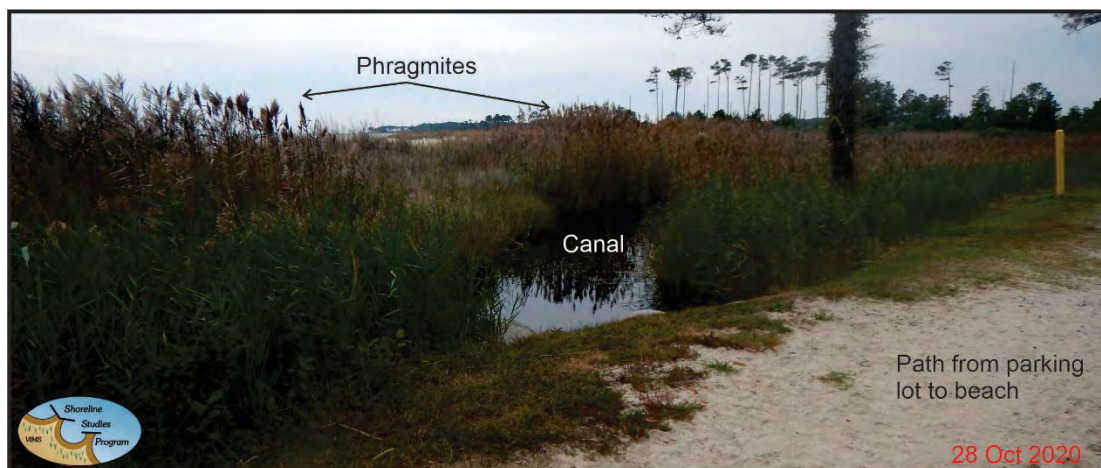
Ground photos show the state of the beach in October 2020. Figure 8-13 shows the northern section of the shoreline. A wide beach and high dune vegetated with dune grasses exists. However, *Phragmites australis* is infiltrating the site. It occurs in the marsh behind the beach/dune system on the northern end of the project. Though erosion is not affecting the marsh behind the system, sea-level rise is. The trees behind the marsh are dying as sea level rises creating a ghost forest. Figure 8-14 shows the tombolo behind the large breakwater and how heavily vegetated it is. Beach and dune grasses effectively hold the sand and provide a buffer for wind transport. Figure 8-15 displays the peat terrace and beach/dune south of the breakwaters. The marsh is closer to the shoreline along this reach, so the *Phragmites* is closer to the beach. The beach/dune is lower in elevation than in the areas farther north. Much of the marsh behind this project has been infiltrated by *Phragmites* (Figure 8-16).

Figure 8-16. The marsh behind the beach has a great deal of *Phragmites australis* growing. Photo credit: Shoreline Studies Program, VIMS.

Some sites may want to remove the *Phragmites* to allow the native vegetation a chance to recolonize the system. Hazelton et al. (2017) investigated whether management efforts to remove *Phragmites* may act as a disturbance, potentially fostering reinvasion. The research indicated that if passive revegetation is the primary means of restoration, the species that re-establish themselves will likely be similar to those species present in the local subestuary especially *Phragmites*. The prolific and resilient *Phragmites* may require diverse treatments, such as mowing, grazing, and burning, or active revegetation. If spraying *Phragmites* is the only option, research results suggest that herbicide treatment must continue in perpetuity (Hazelton, 2018).

Elsey-Quirk and Leck (2020) found that planting native vegetation to outcompete *Phragmites* seedlings and total removal of *Phragmites* to cut off the seed supply may be necessary for successful longer-term restoration and establishment of native species.

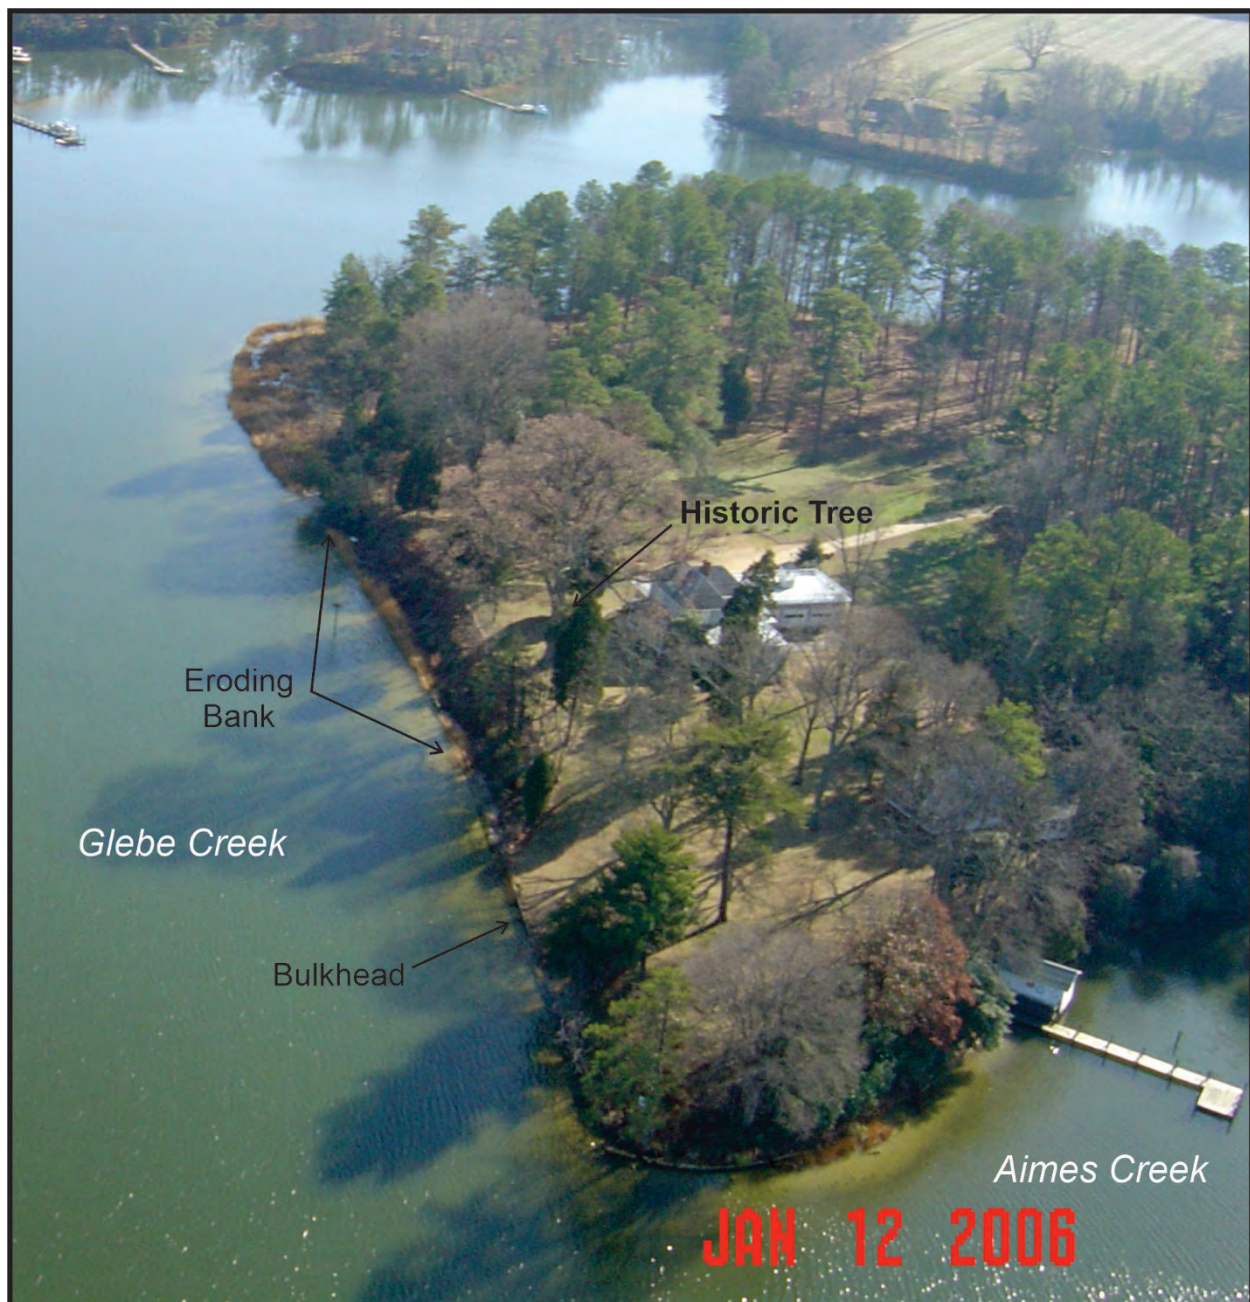
Figure 9-4. Aerial photo of the peninsula that Hull Springs Farm sits on. The shoreline has a high eroding bank and a failing bulkhead. The historic tree was a key part of the project design. Photo credit: Shoreline Studies Program, VIMS.

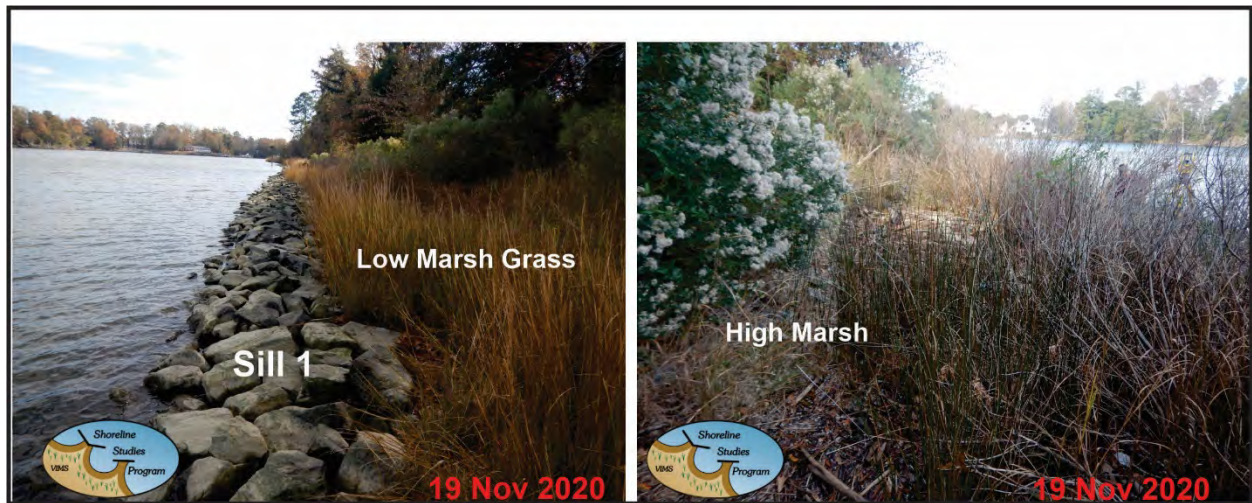
Twelve years after installation, the sill structure remains intact (Figure 9-17). In addition, the low marsh has nearly 100% coverage behind sill 1. The upper limit of *S. alterniflora* was measured at about +1.5 ft MLW. Two other marsh species have colonized into the site, black needle rush (*Juncus roemerianus*) and three-square bulrush (*Schoenoplectus pungens*). The upper limit of black needle rush was measured at +1.6 ft MLW. Tide range is 1.8 ft MLW. The high marsh has more vegetation than in previous years behind sill 1, but bare spots occur. The scrub/shrub has grown into the backshore in this area. The cobble gap is vegetation free and allows access to the water (Figure 9-18). However, with time, the invasion of *Phragmites* along parts of Sill 1 and Sill 2 forced the Longwood University to initiate an eradication program which killed much of the healthy marsh grass too (Figure 9-19). The backshore is bare in areas as the native vegetation tries to recolonize those areas. Still, most of the marsh away from this area is intact.

Figure 9-17. Ground photos of the site after 12 years showing the low marsh and high marsh areas of the sill. Photo credit: VIMS, Shoreline Studies Program.

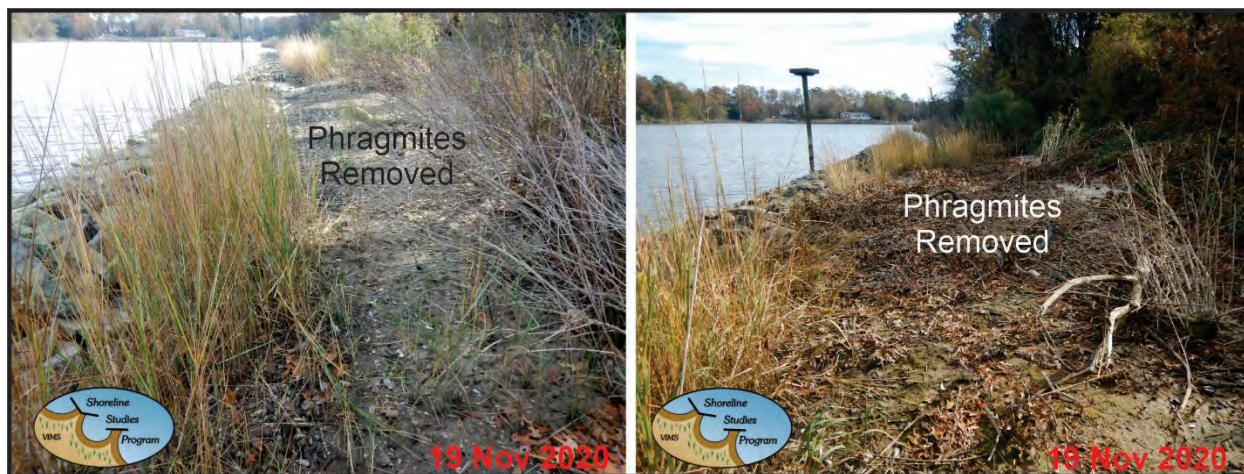
Figure 9-19. Bare spots behind the sill where *Phragmites* was eradicated and native grasses have not grown back yet. Photo credit: VIMS, Shoreline Studies Program.

- Determining why bare spots occur in the marsh is required because it will provide the action needed to remedy the situation. If the bare spot is due to shading, trees can be trimmed. If it is due to the low elevation of the marsh substrate which causes flooding, additional sand may be needed to raise the elevation. Overland or spring freshwater flows may be affecting marsh growth and may need to be redirected.

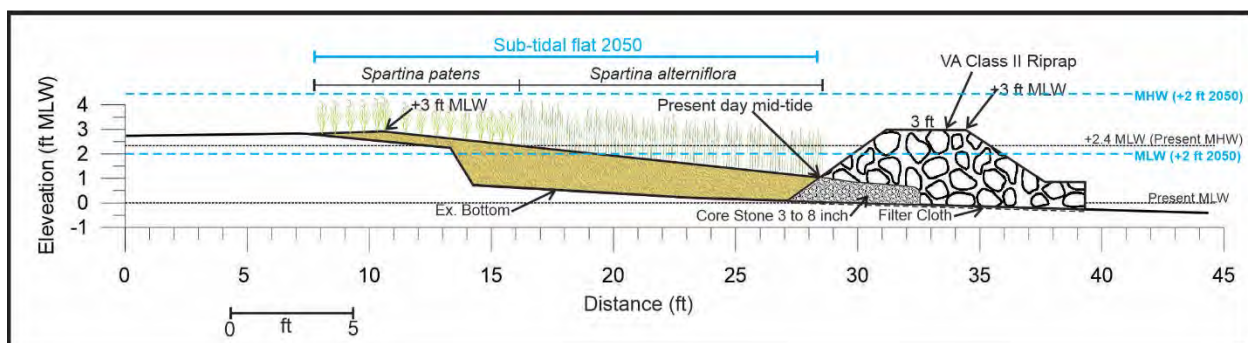
Figure 10-1. A typical low bank sill cross-section (Captain Sinclair Recreational Area) showing the design components as well as the projected sea levels in 2050 (blue). This low system is backed by a wide, low marsh so the marsh will be flooded, but the sill structure would become a nearshore reef. After Hardaway et al. (2018).

When a sill system has a low backshore, adding rock to raise the elevation of the structure is not an option because the upland will flood (Figure 10-1). However, as the marsh

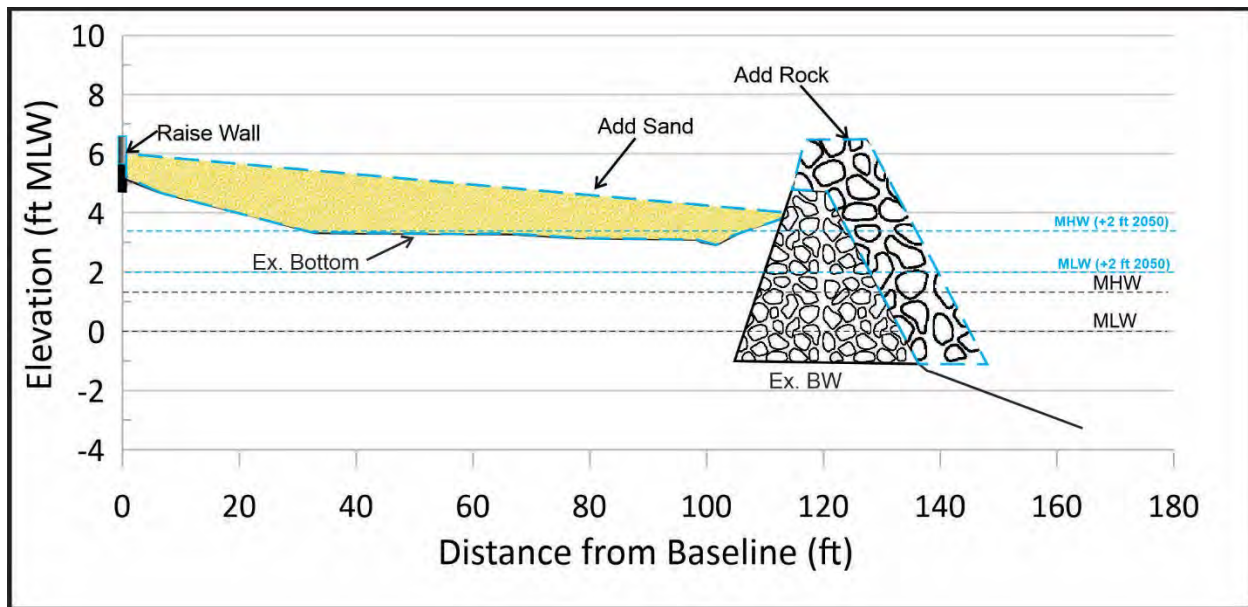
Figure 10-2. A typical cross-section of existing conditions at a low bank breakwater site (Aquia Landing). The system is backed by a low wall that could be raised to contain the added sand to adapt the system to 2050 projected sea levels (blue). Rock could be added to the breakwater structures. After Hardaway et al. (2019).

Breakwater sites that have a low shore can benefit from adding rock and sand to enhance morphologic resiliency (Figure 10-2). As the height of each structure is raised, the front slope extends farther bayward, and the structure gets longer. With a 2-foot increase, the breakwaters could each increase by 9 to 10 feet on each end resulting in an 18 to 20 feet increase in breakwater length. By closing the gap between the structures, the newly elevated beach planform will be further stabilized. The new armor should be at least 2-3 feet higher to accommodate the required rock size (1 to 2-ton armor stone). The shore planform can only adjust vertically with sea-level rise unless the system is moved offshore. Determining the cost of the rock and sand volume to move the breakwaters offshore is needed to find out if it is cost-effective.

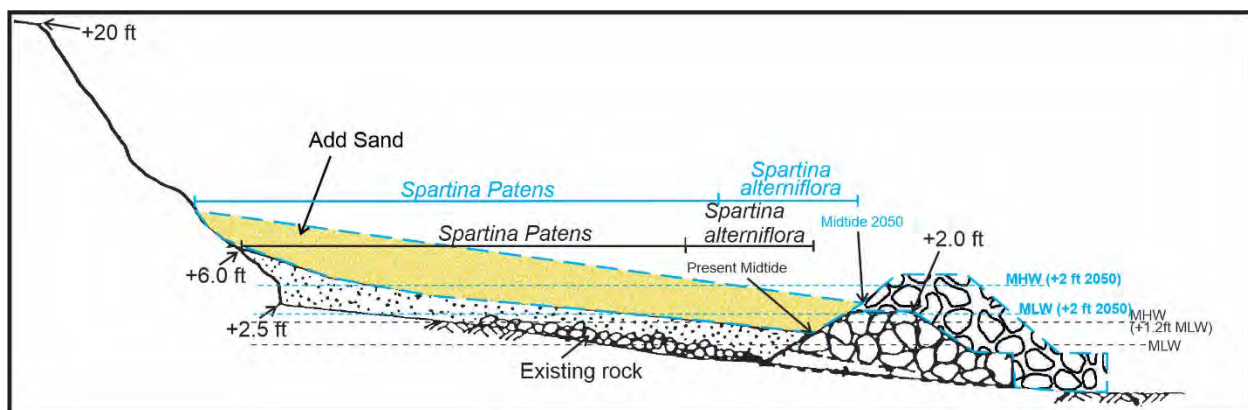
The sills that had high banks included Hull Springs Farm, Jefferson Patterson Park and Museum, St. Mary's City, and Werowocomoco. The high bank breakwater sites were Kingsmill and VIMS East. Under the coastal squeeze scenario, the structures will require an increase in elevation with additional rock and sand as sea level rises because the marsh will not be able to migrate up the bank (Figure 10-3).

Figure 10-3. A high bank sill system (Jefferson Patterson) typical cross-section showing the design conditions at the site as well as the projected 2050 tide level (blue). Rock and sand can be added to the system to maintain its effectiveness. To not squeeze the system, rock would need to be added to the outside of the structure. After Hardaway et al., (2018).

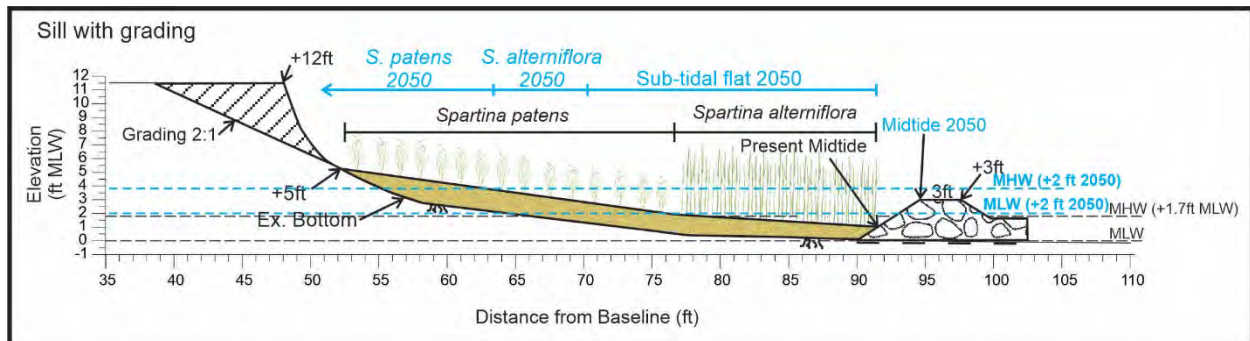
For some mid-sized banks, grading could be an option if infrastructure is not close to the shoreline (Figure 10-4). A 2:1 slope is generally recommended for stability, but if space allows, a 4:1 slope will allow more marsh migration up a gentler slope. However, the amount of material that will need to be disposed is a large consideration.

Figure 10-4. A high bank sill system typical design cross-section showing the adaptation to 2050 tide levels (blue). The top of the bank can be graded which will allow the marsh to migrate up the bank. The area behind the structure would become an intertidal and subtidal flat and only top of the structure would be at about mid-tide. Sill system at Occohannock on the Bay in Accomack County, after Hardaway et al. (2018).
