# **Living Shoreline Sea-Level Resiliency: Performance and Adaptive Management of Existing Sites**

## **Year 3 Summary Report**

**Donna A. Milligan  
C. Scott Hardaway, Jr.  
Christine A. Wilcox  
Nick J. DiNapoli**

**Shoreline Studies Program  
Virginia Institute of Marine Science  
William & Mary**

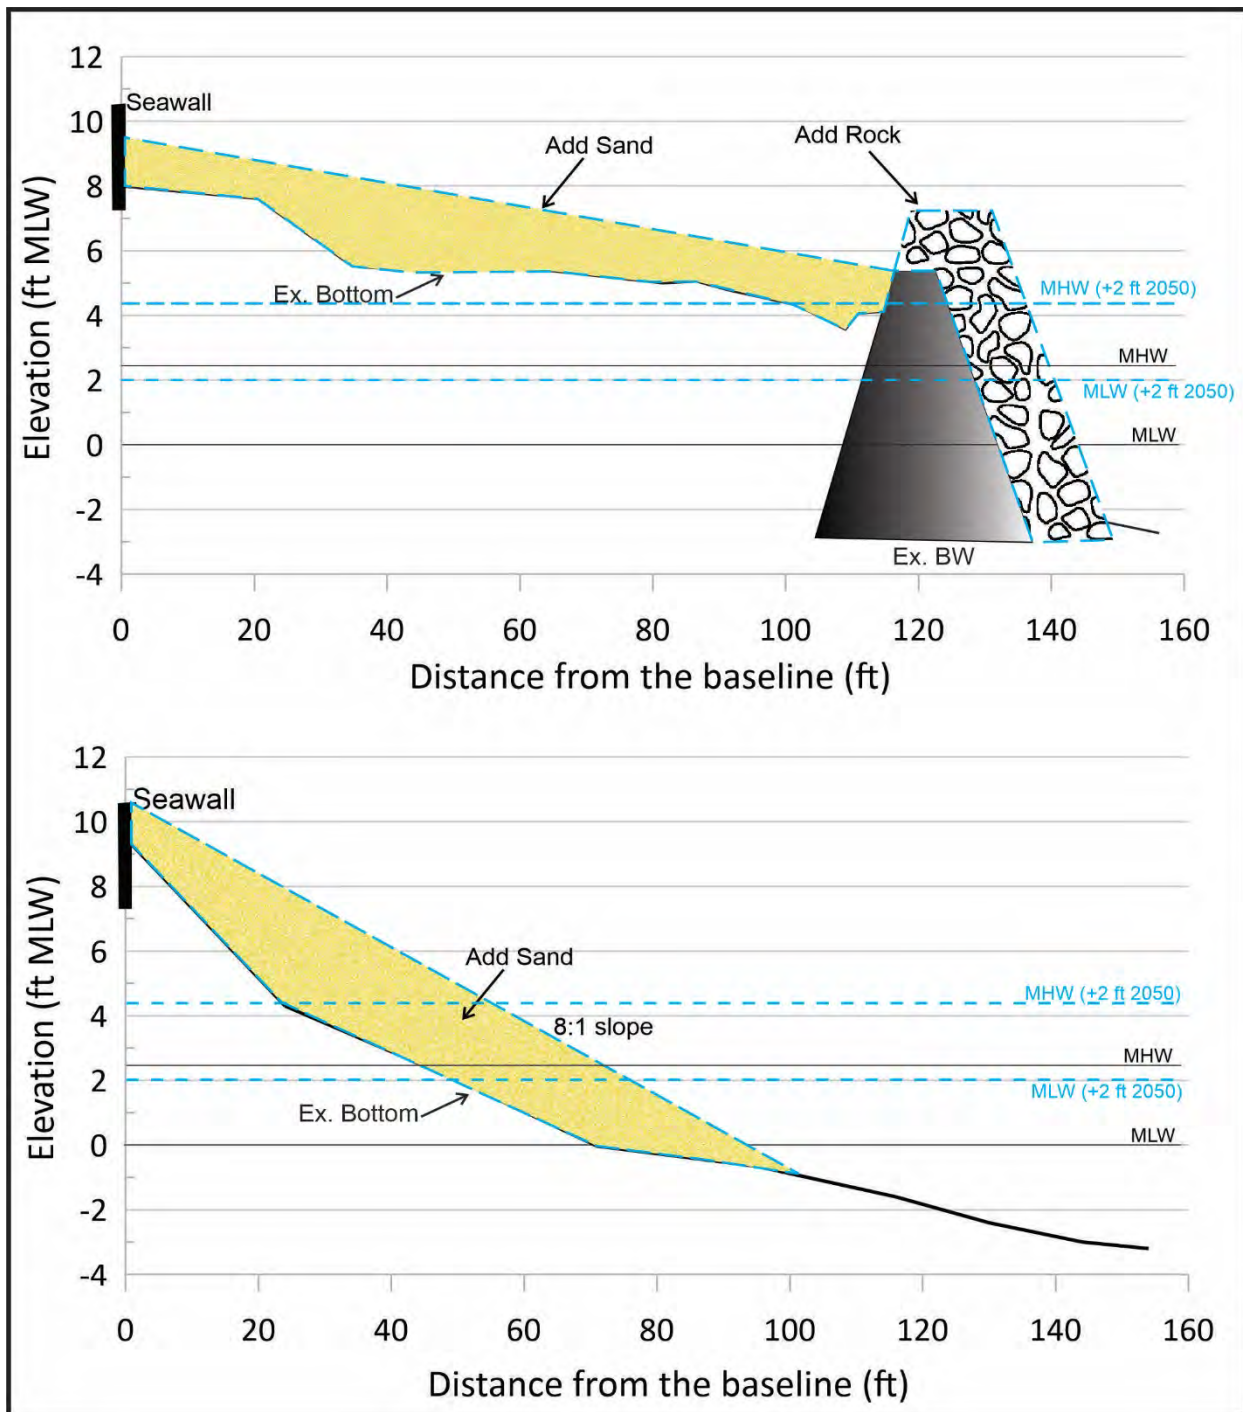
As with structures adjacent to low banks, when rock is added to structures adjacent to high banks and the height of each structure is raised, the front slope extends farther bayward and the structure gets longer (Figure 10-5). The new armor should be at least 2-3 feet higher to accommodate the required rock size (1 to 2-ton armor stone). This also increases the structure's

Figure 10-5. Existing conditions at a high bank breakwater site (VIMS East). The land continues to rise behind the seawall and infrastructure exists so the site could not be graded. To raise the elevation of the system to adjust for the projected 2050 tide level (blue) rock can be added to the structures. In addition, sand can be added behind the structures and in the embayments to enhance adaptability. After Hardaway et al., (2019).
