Machicomoco State Park Shoreline Management Plan

May 2022

**Shoreline Studies Program
Virginia Institute of Marine Science
William & Mary**

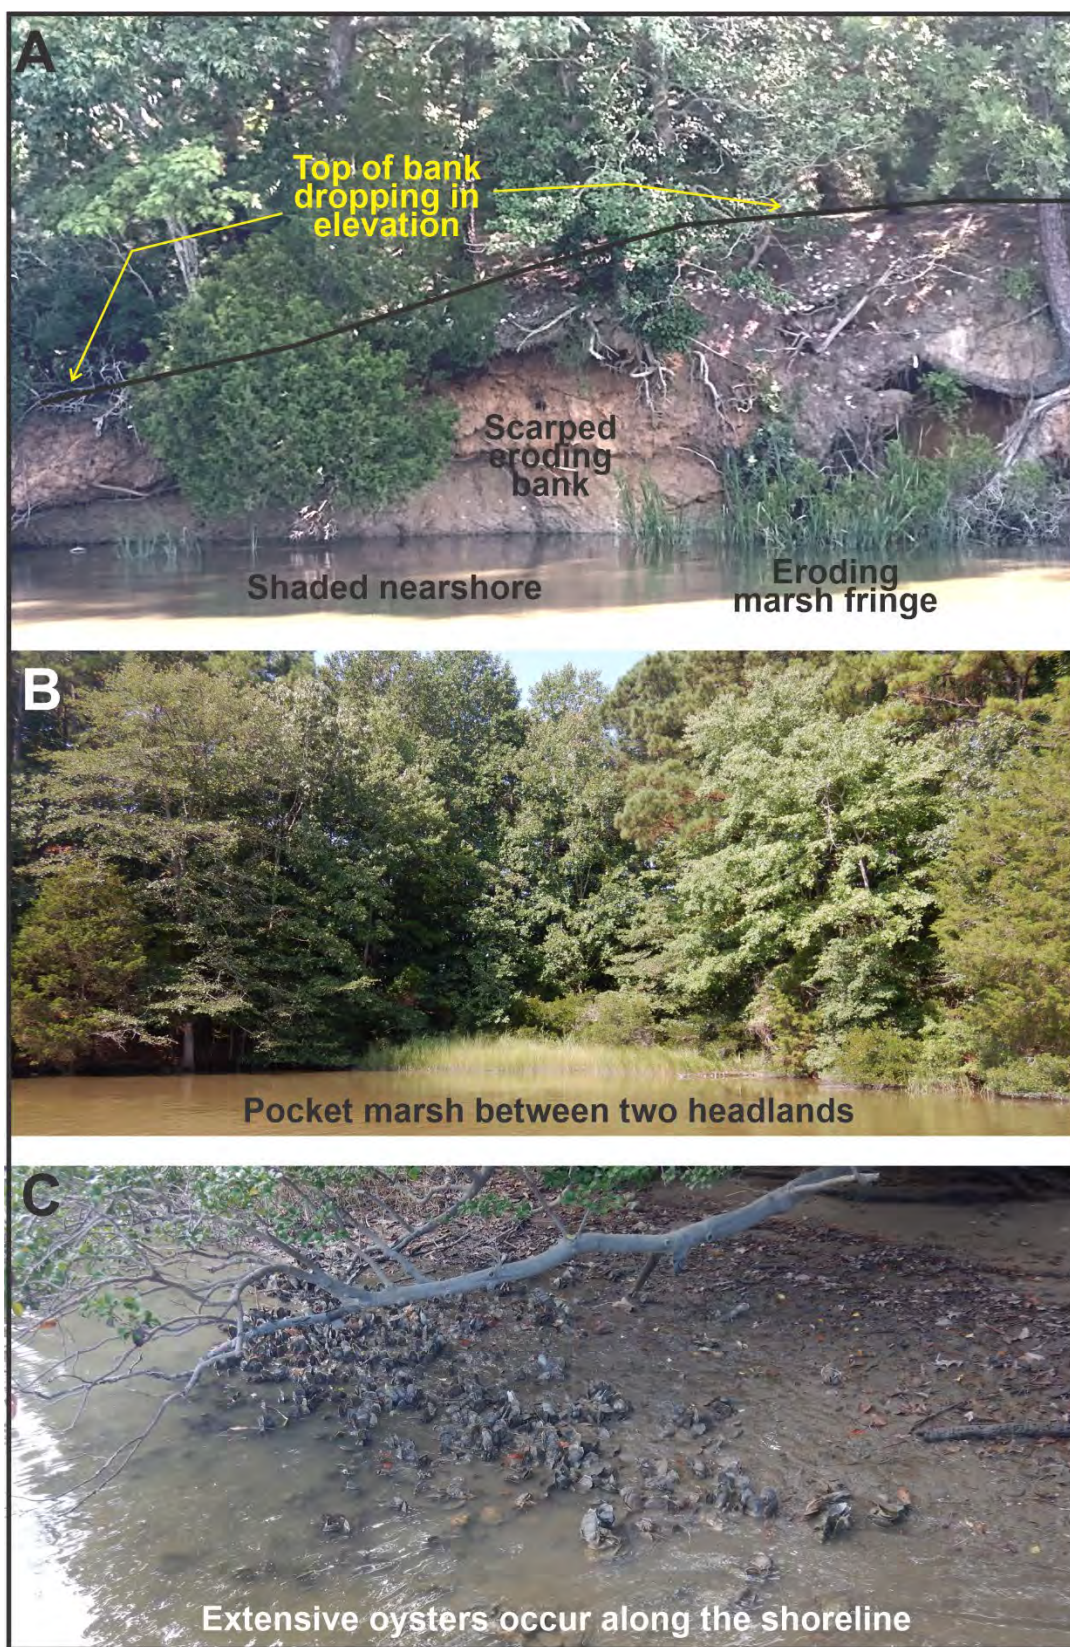
Machicomoco, NAVD88 is 1.3 ft above mean low water (MLW) (Hardaway et al., 2021). Much of the MSP shoreline has a high bank that is eroding or undercut in many places as the heavily forested areas along the shoreline shade out the fringe marsh (Figure 4A). Small, lower pocket marshes, visible on Figure 3, occur between the higher forested points of land that extend farther into the Creeks (Figure 4B). Bank height affects the nature of erosion. Though waves impact the base of any eroding bank, the long-term fate of the bank slope will depend on bank height and composition. During severe storms, the waves may overtop lower banks or directly act on the bank face of a higher bank.

Figure 4. Photos taken of the MSP shoreline in 2021 showing A) an eroding bank face, B) a pocket marsh, and C) oysters along the shoreline.

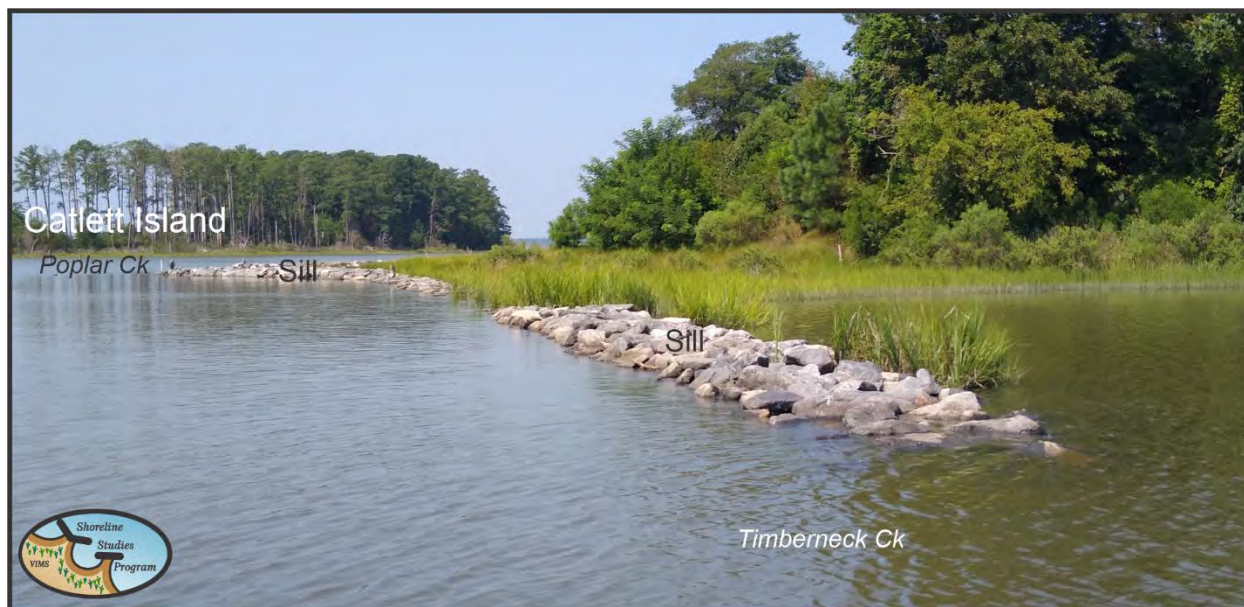
Figure 6. Sill constructed at the southeastern tip of the park on Timberneck Creek in 2011. Photo date 24 Aug 2021. Lat/long location: 37.294578°, -76.534841°

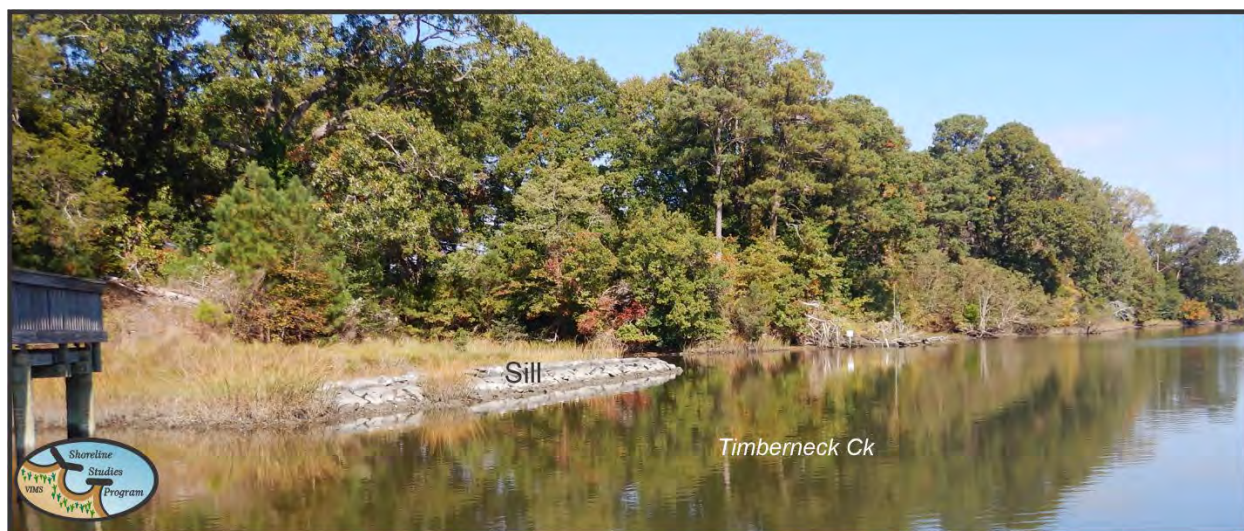
Over time, several structures have been built along the shoreline to mitigate erosion or for recreational purposes. One 210 ft pier exists along the southern shore of the park in Poplar Creek and provides car-top launch access, and two more piers, one west of the southeast point and approximately 115 ft long is suitable for nature viewing; the other, which also includes a floating boat dock, is approximately 518 ft long occurs along the southeastern shore in Timberneck Creek (Figure 2). Permitted by Timberneck, LLC, designed by Williamsburg Environmental Group, and constructed by Coastal Design & Construction, Inc. of Gloucester, Virginia, a gapped sill system along the southeastern point in early 2011, the first one measuring 120 ft and the second measuring 265 ft in length, and each ranging in height from +5 ft MLW on the ends to +3.5 ft MLW in the center (Figure 6) More details on the project are shown in Appendix B. The same company also constructed a single sill measuring 85 ft long and +3.5 ft MLW high just north of the largest pier and boat dock (Figure 7).

Figure 7. Sill constructed adjacent to the pier on Timberneck Creek. Photo Date 1 Nov 2021. Lat/long location: 37.297472°, -76.533842°

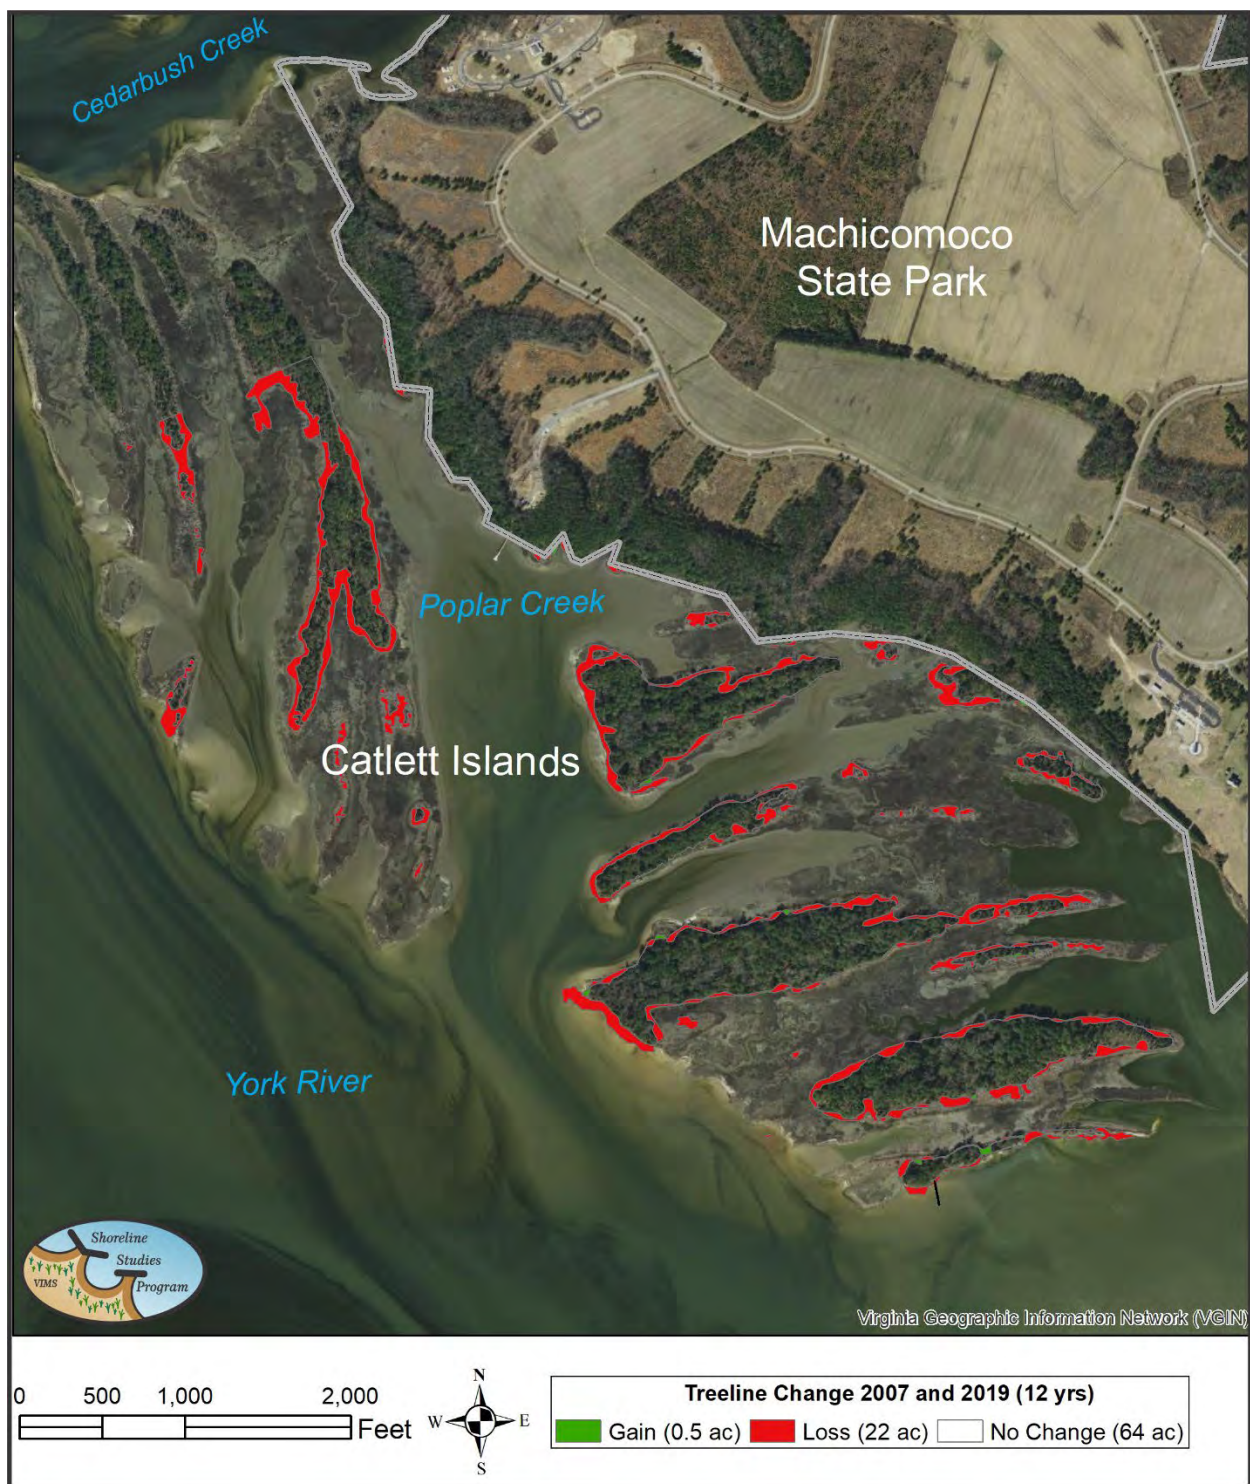
In addition to changes in the shorelines of the area, vegetation zones also experienced shifts from 2007 to 2019. On the Catlett Islands, there was an overall conversion of 22 acres of ghost trees/maritime forest upland zone to high marsh (Figure 10). As sea level has risen, the marsh migrates to higher elevations. Around the fringes of the Islands, the ghost forest/maritime forest habitats are being lost to erosion. Catlett is generally much lower than MSP's shoreline which is backed by a high bank. As a result, it is much more susceptible to higher water levels. However, as sea-level continues to rise, MSP will begin to be affected, particularly in the lower, pocket marshes and along the lower shoreline directly adjacent to the Islands.

Sea level rise was calculated to be 4.9 mm/yr (NOAA Tides and Currents, 2021). Based on this rate of change, mean sea level has increased vertically by 0.2 ft since 2007. Though this seems like a small amount of water, over the gradual slopes in the marsh, it can affect a large area horizontally. This accounts for the internal conversion of the upland forests to marsh shown in Figure 10.

Figure 10. Loss of upland trees at Catlett. Due to sea-level rise, the tree line is being converted to marsh as it migrates higher in elevation.

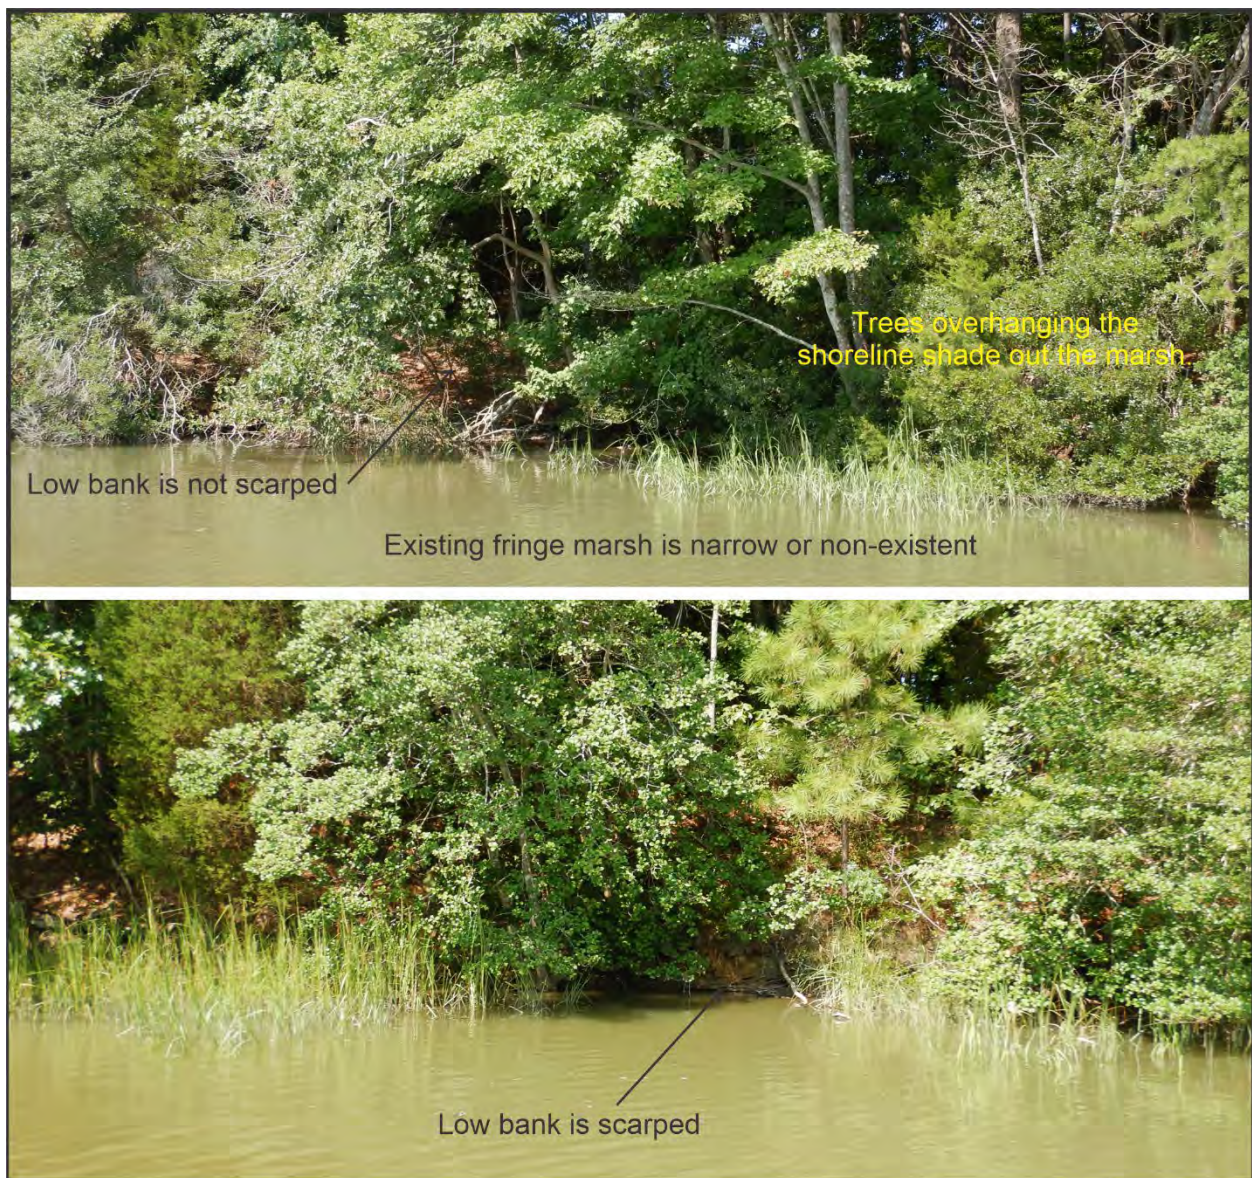
Figure 20. Photos taken along Reach 1 in Timberneck Creek. The two sites are directly adjacent to one another. The scarped bank would require more work to become stable.

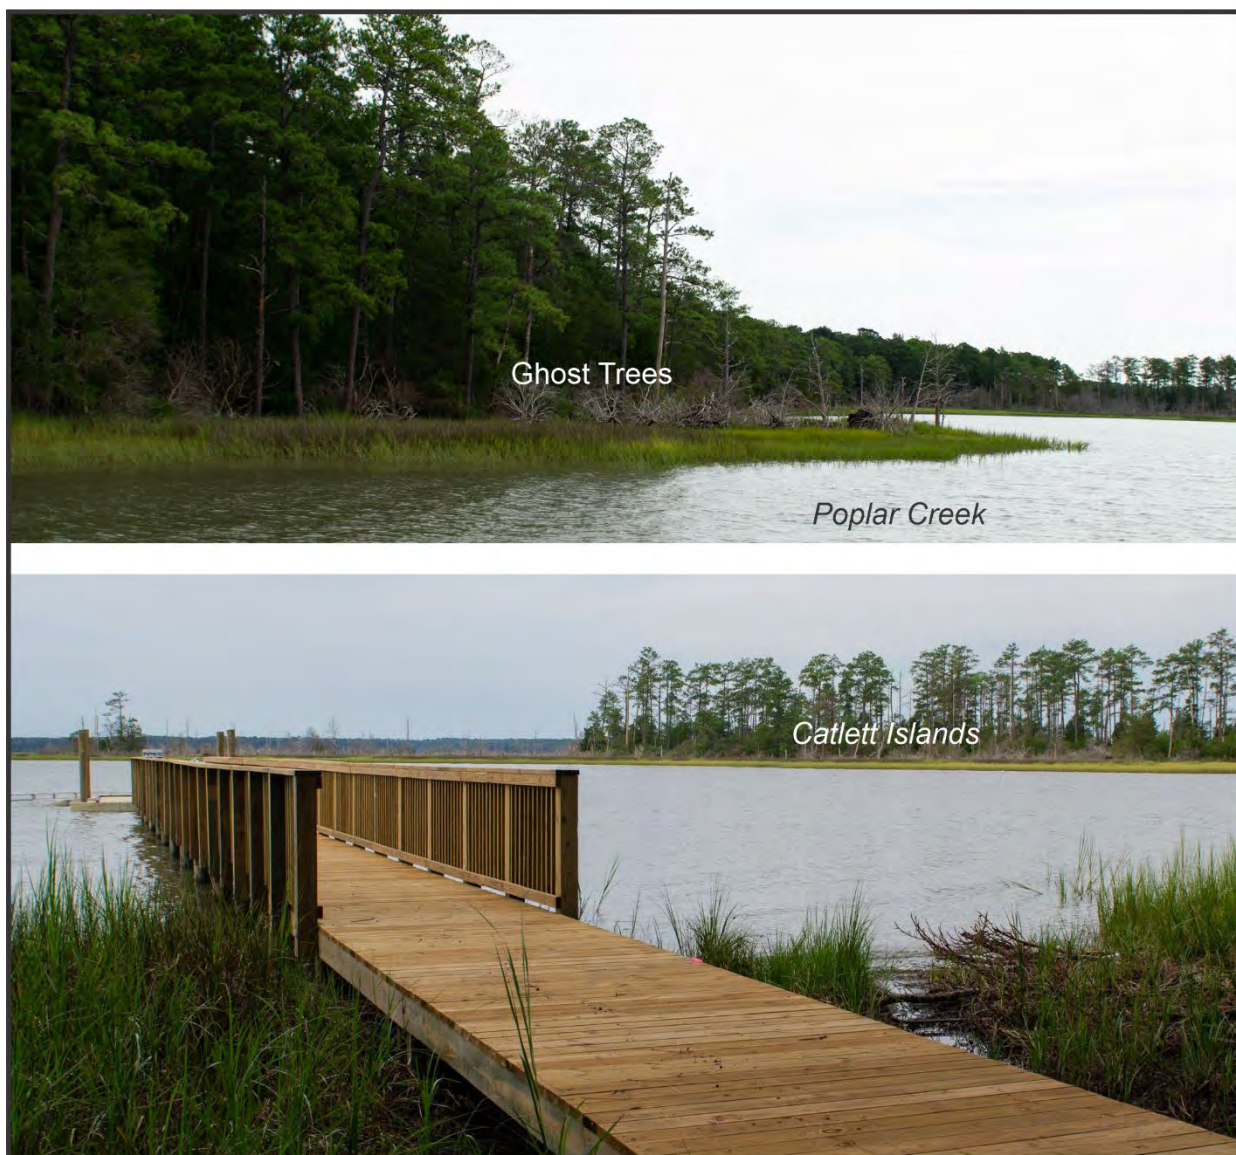
Figure 21. Photos of the shoreline at Site 13 west of the point. Photos courtesy of the Virginia Department of Parks and Recreation.

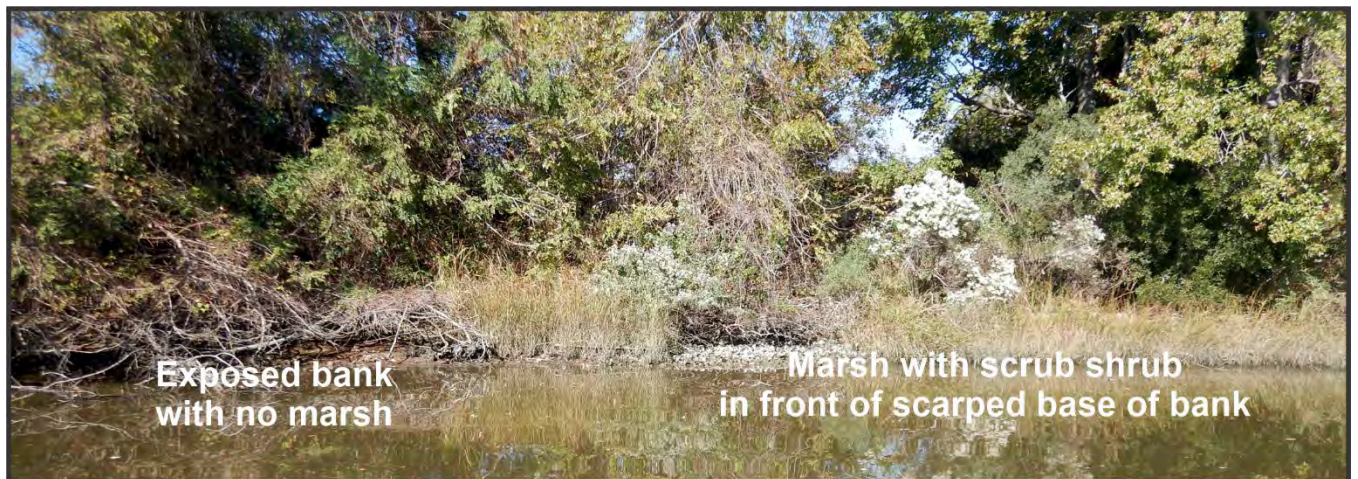
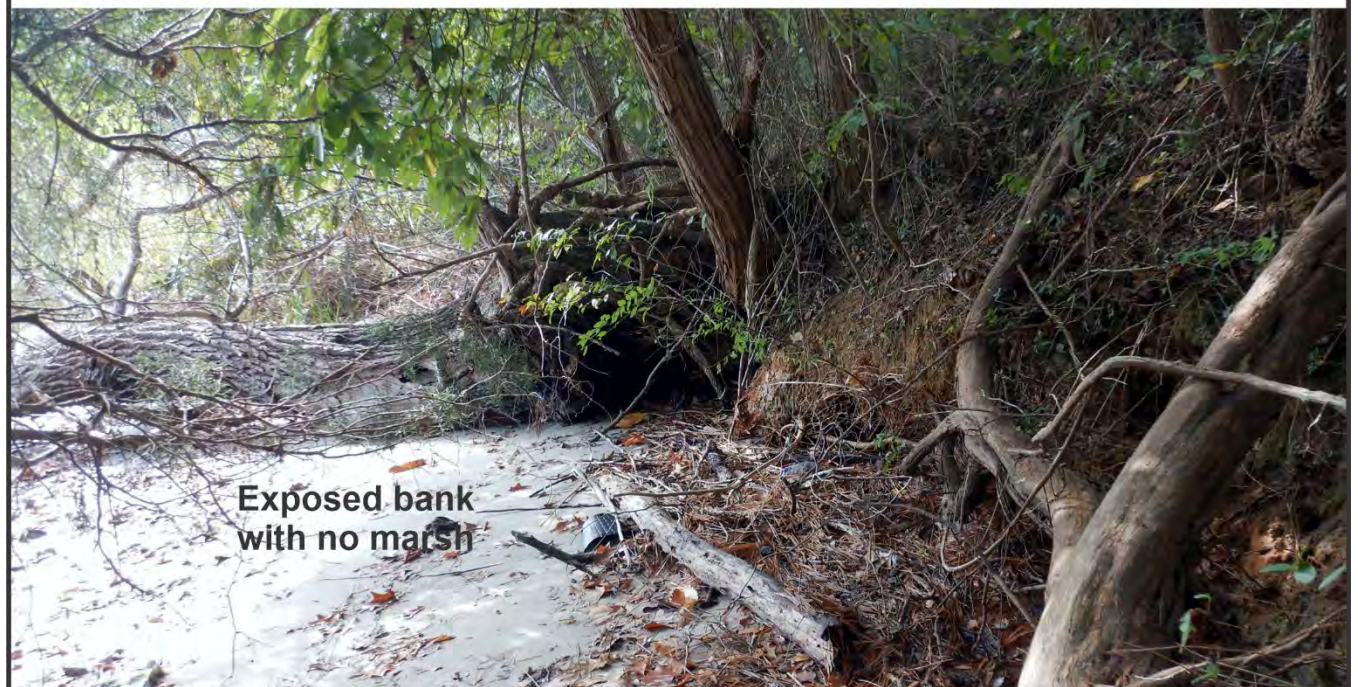
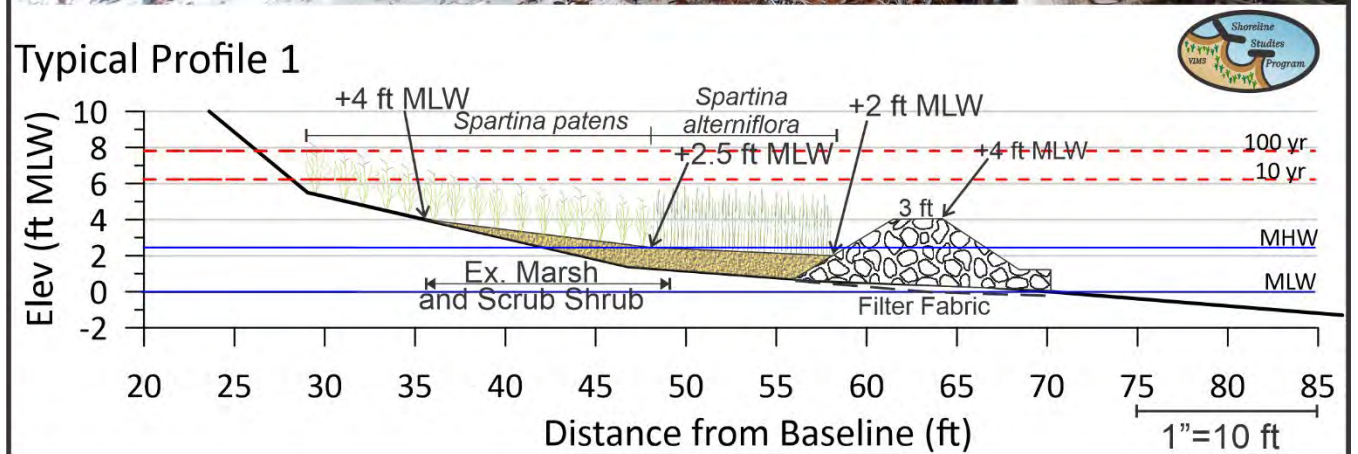
Figure 25. Photos showing the (top) northern section of sill 1 with its marsh and scrub shrub and (middle) the southern section of sill 1 where no marsh exists. The bottom is the typical profile of sill 1. However, it shows the northern section, not the southern section.

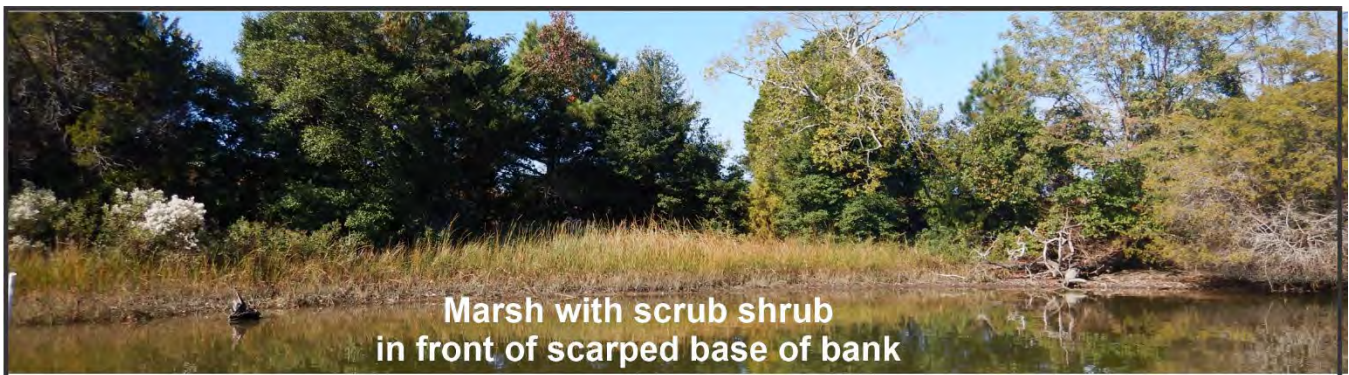
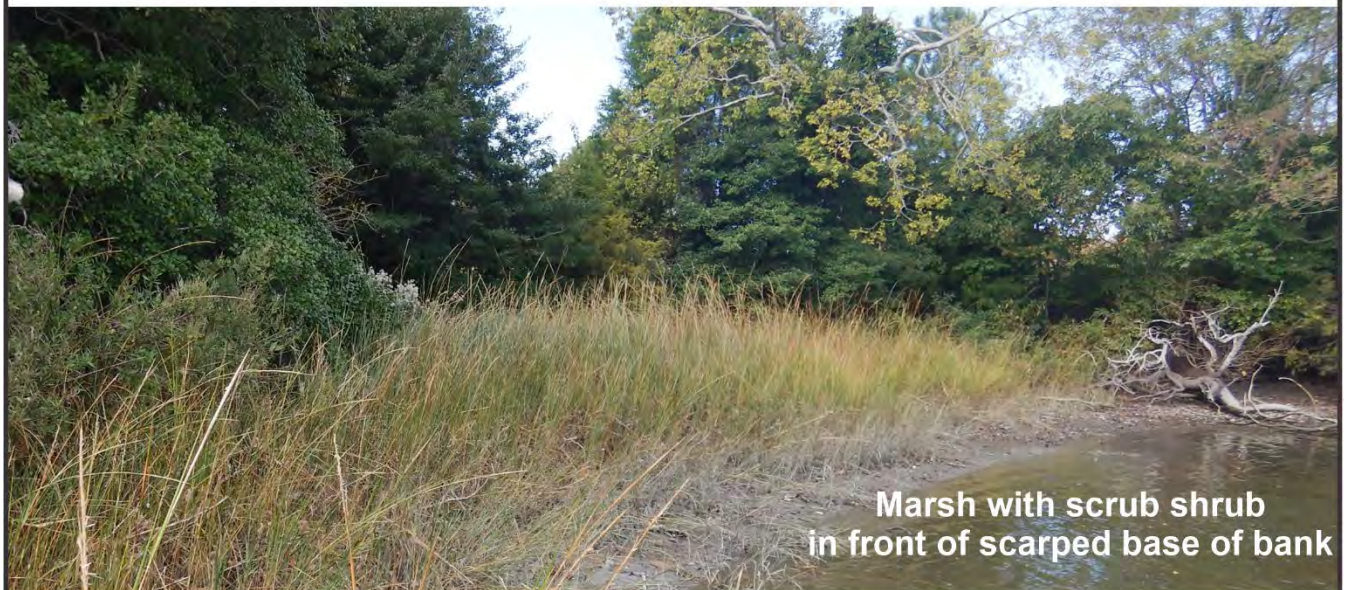
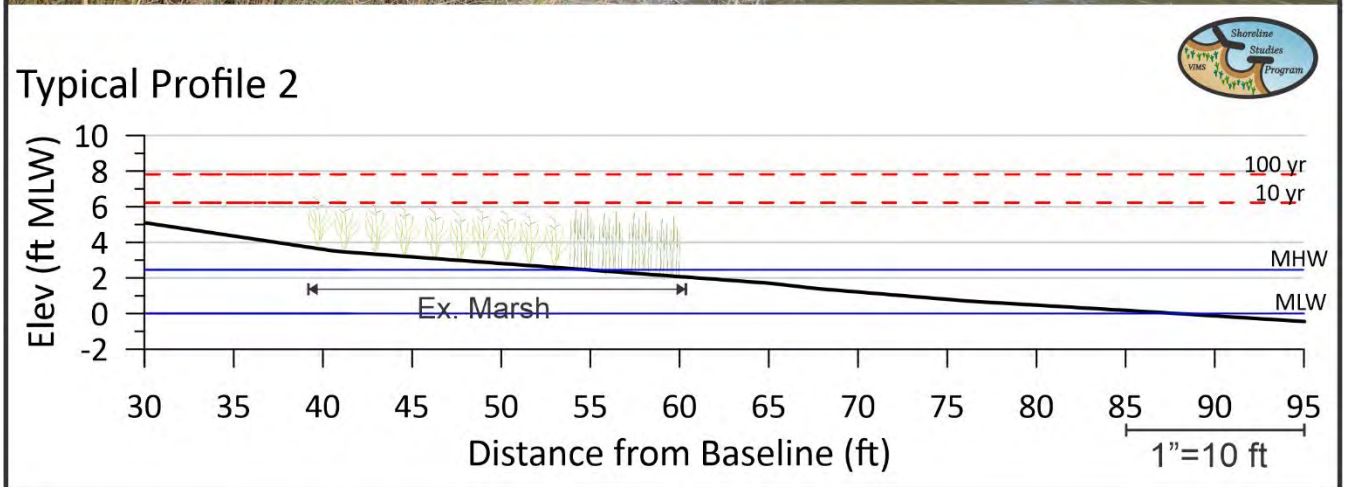
Figure 26. Photos showing the gap between sills 1 and 2. A wide marsh with a gentle slope exists here. The typical profile shows that no additional sand is needed.

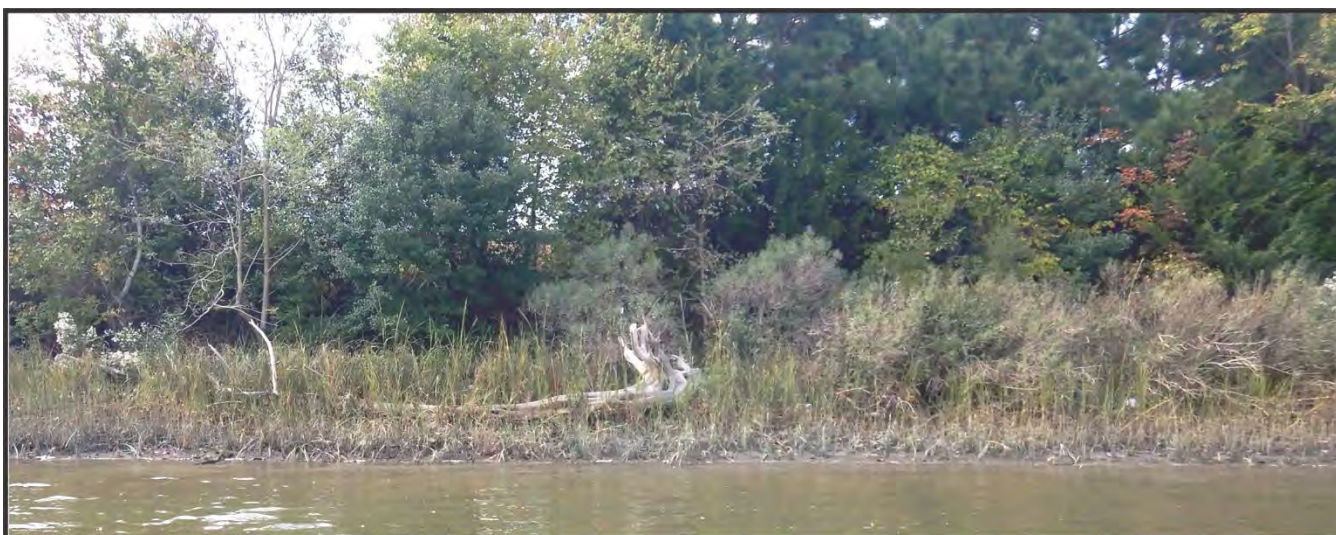
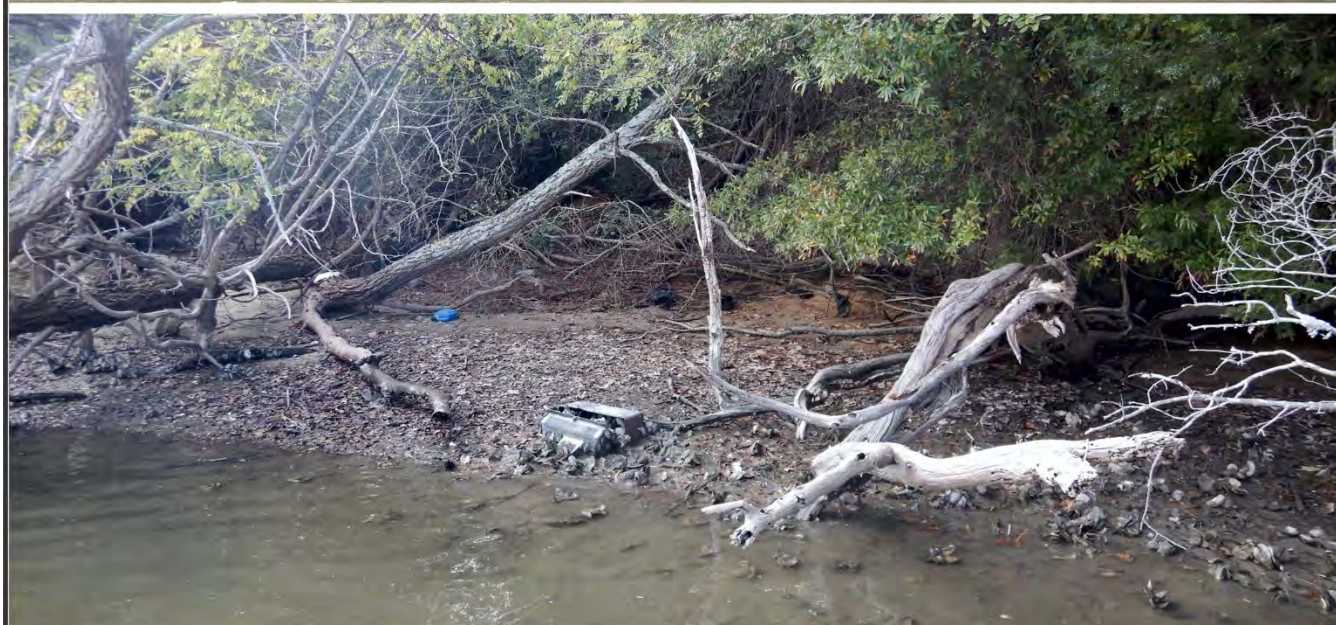
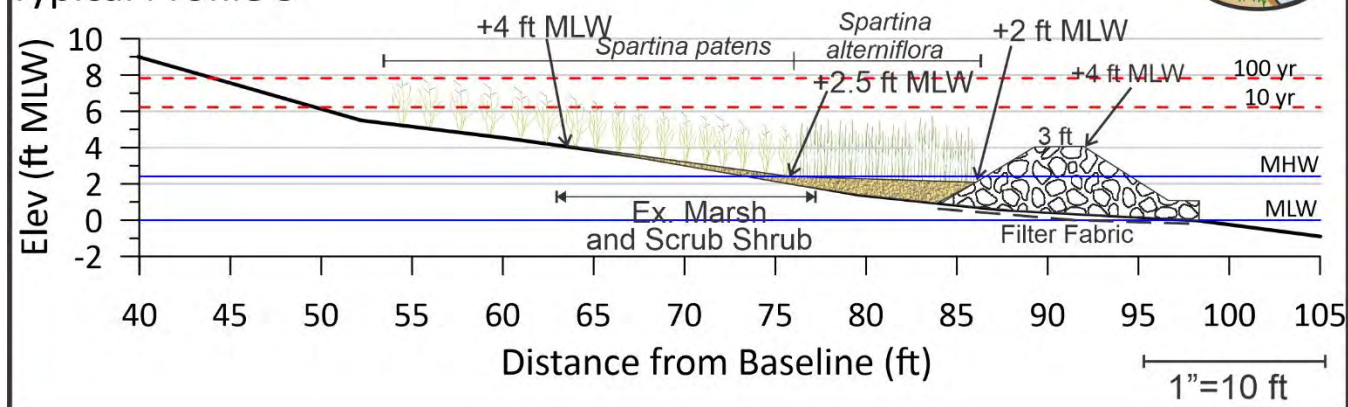
Figure 27. Photos showing the (top) northern section of sill 2 with its marsh and scrub shrub and (middle) the southern section of sill 2 where no marsh exists. The bottom is the typical profile of sill 2. However, it shows the northern section, not the southern section.

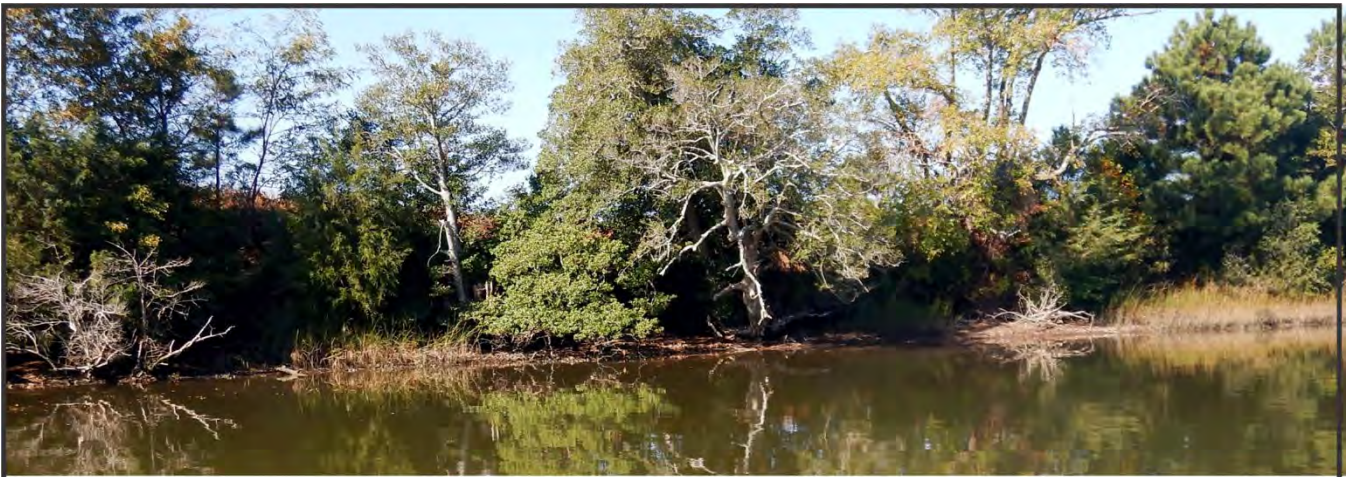
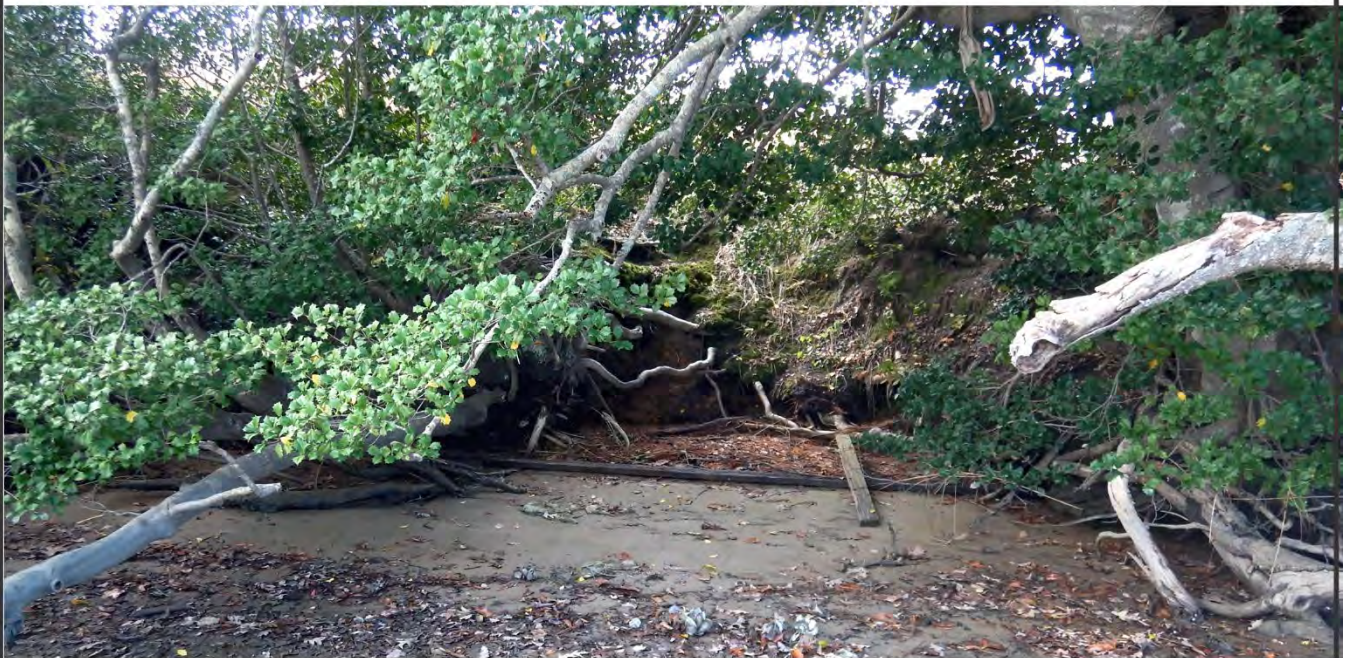
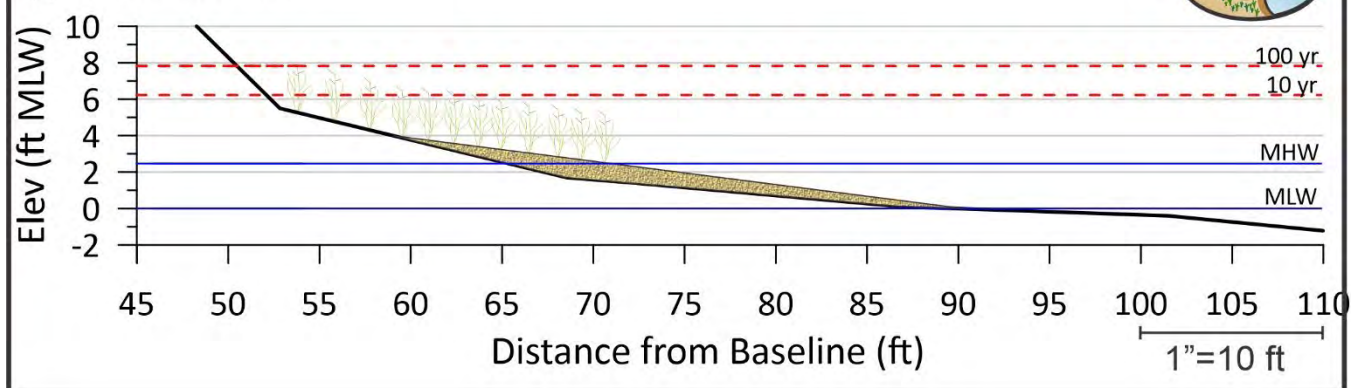
Figure 28. Photos showing the gap between sills 2 and 3. This profile has no marsh and an exposed bank. The typical profile shows that sand and plants are needed.

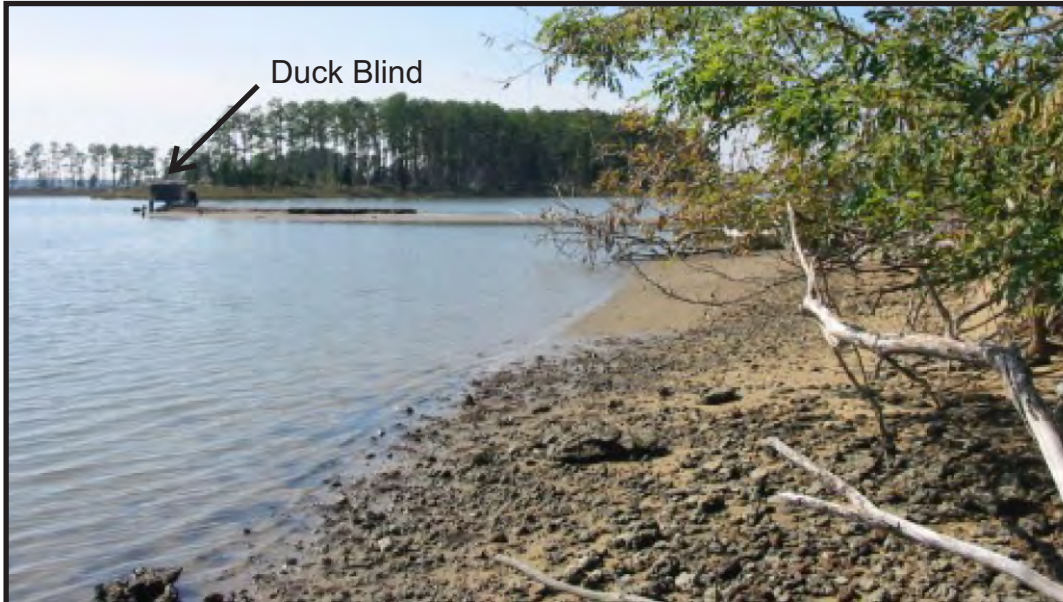
Duck Blind

Photo date: 26 Sep 2010
Eroding upland bank, no
marsh fringe
Photo credit: VMRC Project
Report dated 4 Sep 2009

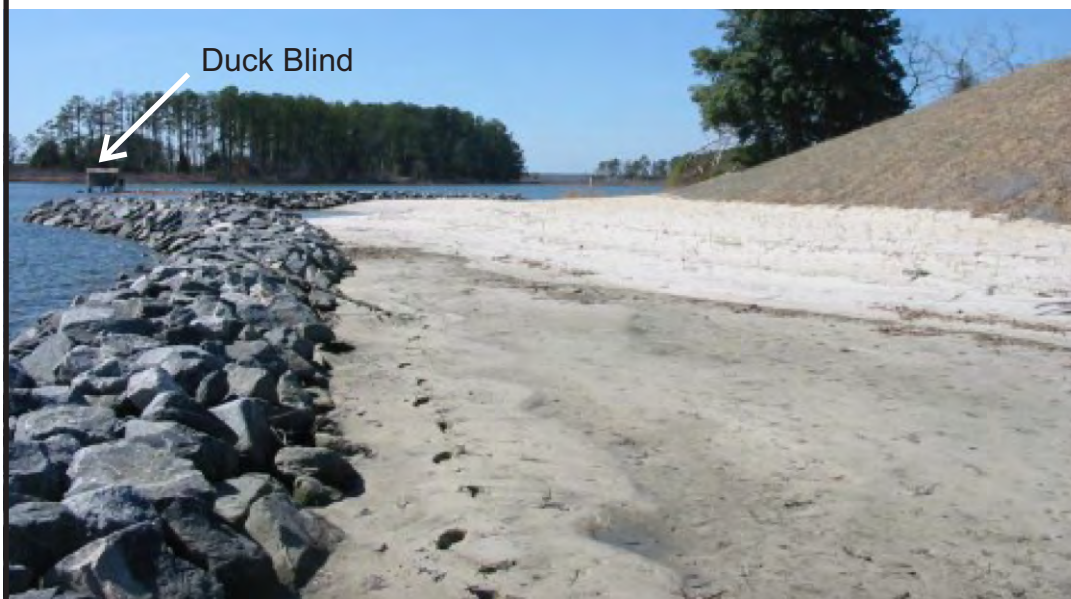
Duck Blind

Photo date: 4 Mar 2011
New sill, placed sand
nourishment,
marsh grass planted,
graded bank
Photo credit: VMRC
Project Report dated 4
Sep 2009

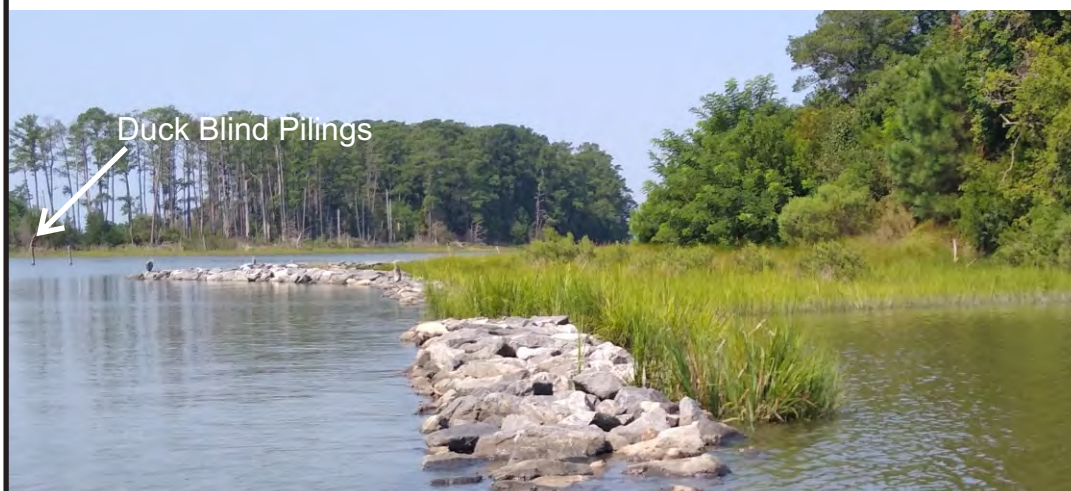
Duck Blind Pilings

Photo date: 24 Aug 2021
The marsh sill 10 years after
construction.
Photo credit: VIMS
Shoreline Studies Program

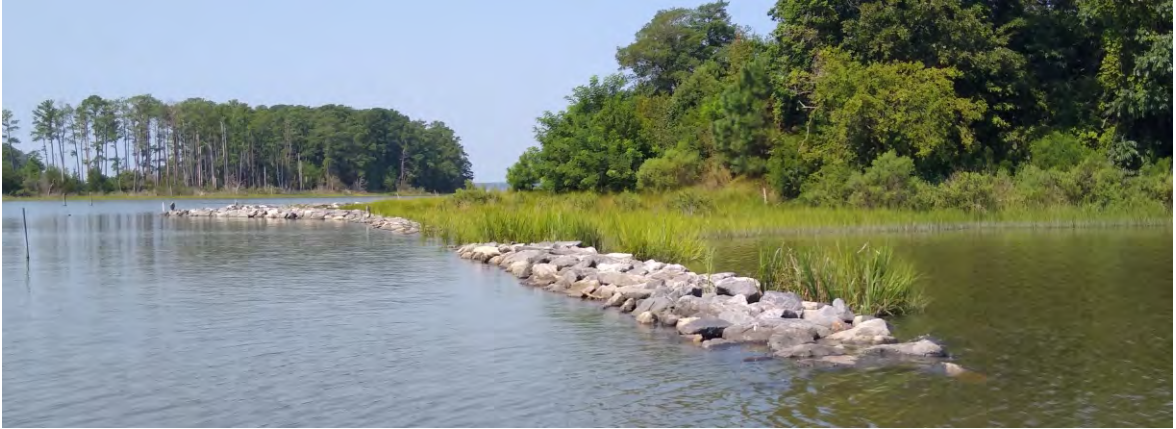
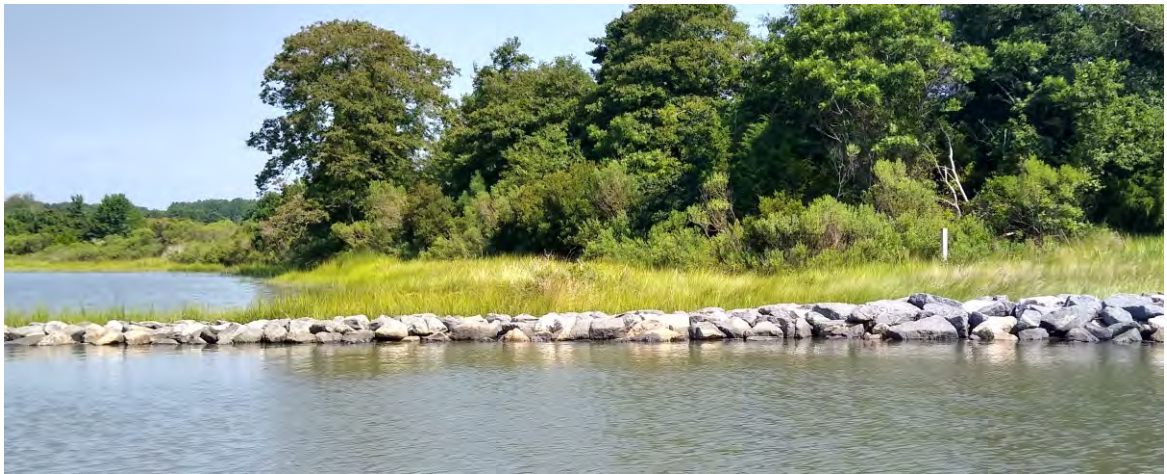
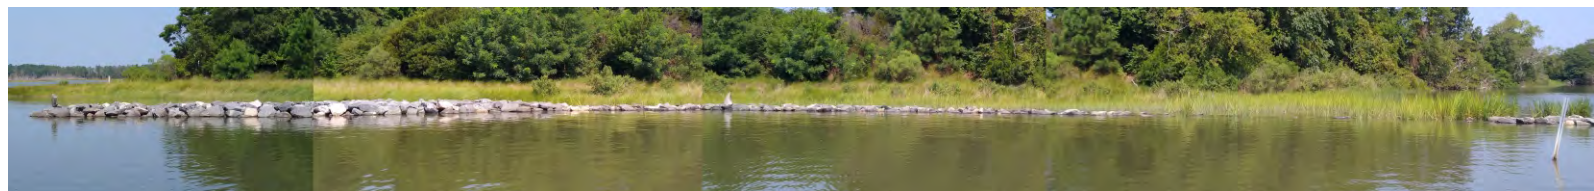
Sill at the Point 10 years after construction

The ends of the sills are designed to be higher than at the center.
Below, the panoramic image shows that the center section is barely above high water though the ends are higher.

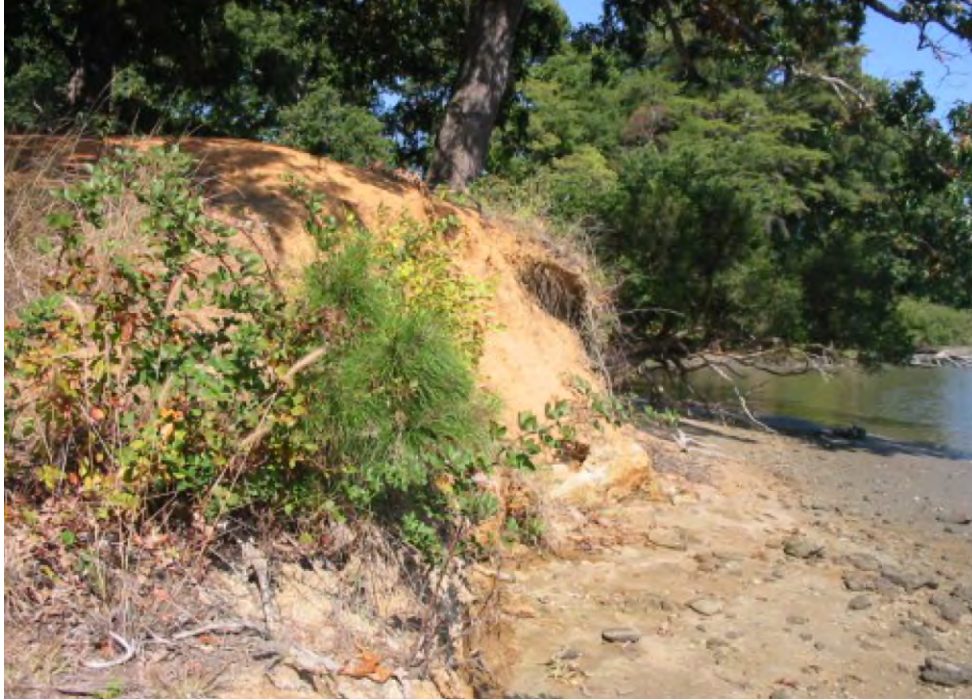
Photo taken 26 Sep 2010
Steep eroding upland bank, no
marsh fringe.
Photo credit: VMRC Project
Report dated 4 Sep 2009

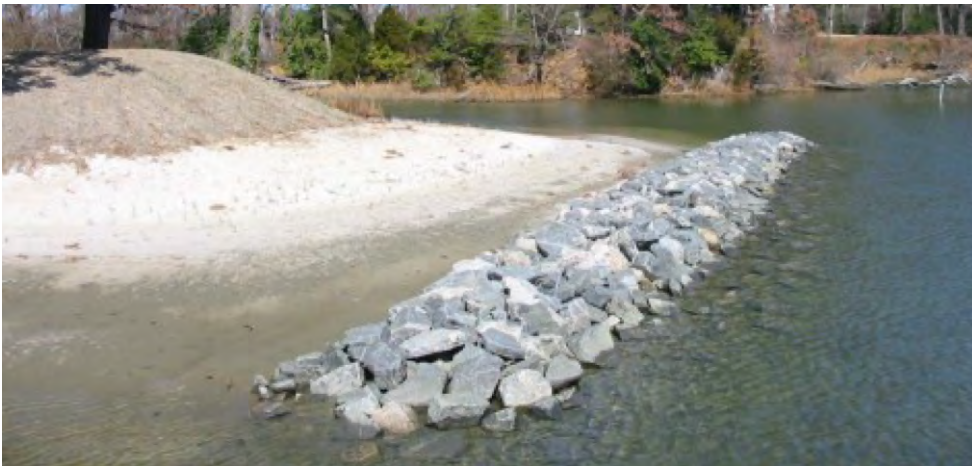
Photo taken 4 Mar 2011 1258
New sill, placed sand nourishment,
marsh grass planted, fill placed
over bank instead
of grading it.
Photo credit: VMRC Project Report
dated 4 Sep 2009

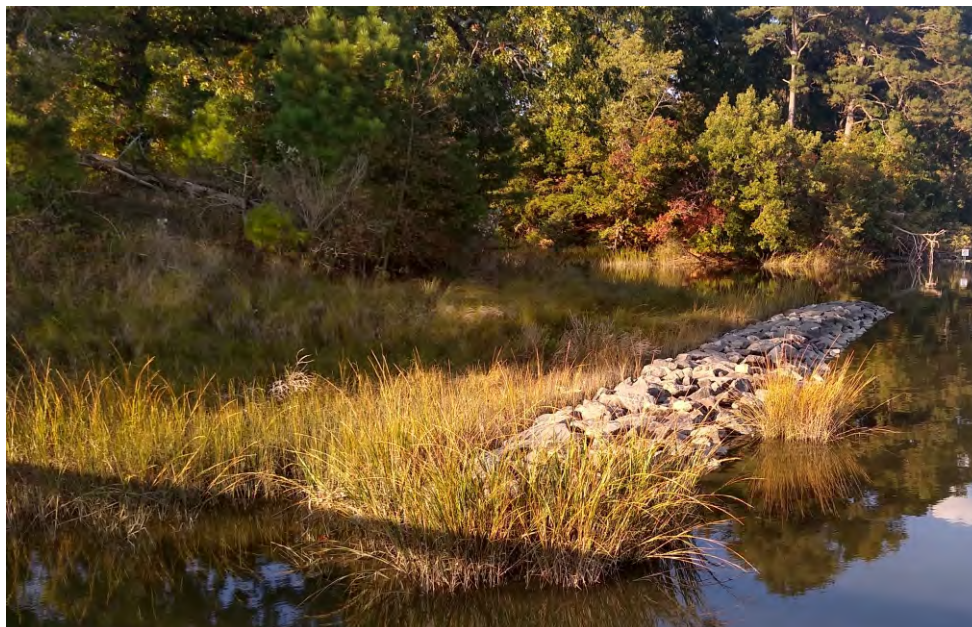
Photo taken 1 Nov 2021
Photo credit: VIMS Shoreline
Studies Program
