## TECHNICAL MEMORANDUM

**Subject:** StormGarden Infiltration Testing at the Ship Canal Testing Facility

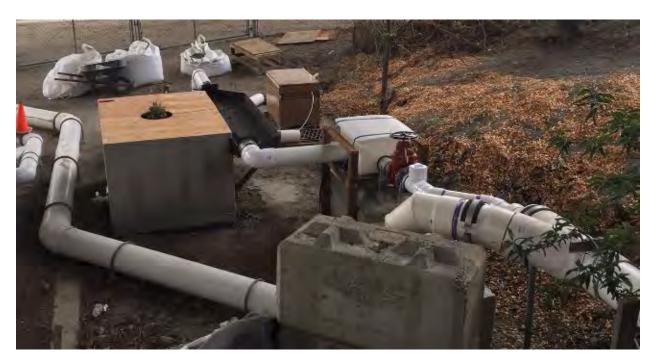
Figure 1. Image of the StormGarden System Tested at the SCTF.

On April 20, 2017, Herrera Environmental Consultants, Inc. (Herrera) conducted infiltration testing on a 4- by 6-foot (internal dimensions) StormGarden Stormwater Filtration System (StormGarden) installed at the Ship Canal Testing Facility (SCTF) in Seattle, Washington (Figure 1). In order to determine the maximum flow rate that the system could infiltrate without bypassing, a firehose with Master Meter™ fire hydrant meter (flow meter) was used to discharge potable water into the system. The flow rate of the flow meter was verified with a calibrated 30-gallon bucket and timer prior to testing, and it was determined that the error was less than 5 percent. Figure 2 provides images of both the flow meter and the graduated bucket.

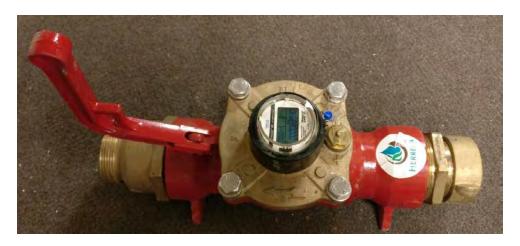
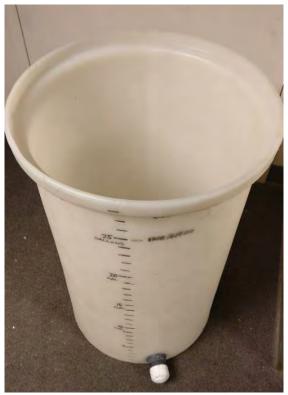
Figure 2. Images of the Rotameter and Graduated Bucket used During the Infiltration Testing.

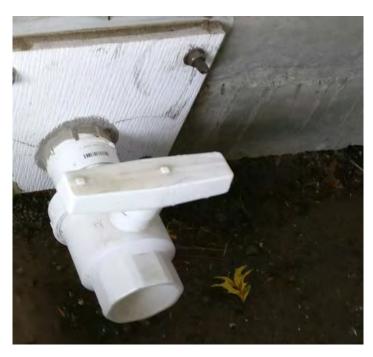
Figure 3. Filter Panel Valve.

The StormGarden is configured with a 4-inch underdrain as well as a 6- by 4-inch permeable paver filter panel that is designed to drain the water beneath the underdrain perforated pipe between storm events. The filter panel also provides some infiltration benefit. During the final run, a valve sealed over the filter panel (Figure 3) was opened and one final infiltration test was run to determine the maximum infiltration rate with both the underdrain and filter panel exporting filtered stormwater. The result was an increased maximum infiltration rate from 213 in/hr to 249 in/hr (Table 1).
